Inspection Report

Report No:	KHT-20250327-033	Sales:	Daniel Yuan	Department Of Application	Sales
Receipt Date:	2025-03-05	Test Date:	2025-03-05	Report Date:	2025-03-27
Inspector:	Wade	Approved by:	David	Approved by:	Jan Guo

Sample Information					
Part Number:	EP4CE40F23I7N	Package Type:	FBGA-484	D/C:	2307+
Package Carrier:	TRAY	Manufacturer:	ALTERA	MSL:	3
Quantity Received:	180pcs	Quantity Inspected:	5pcs	PO Number:	1215075524

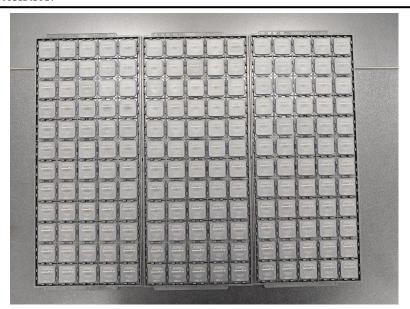
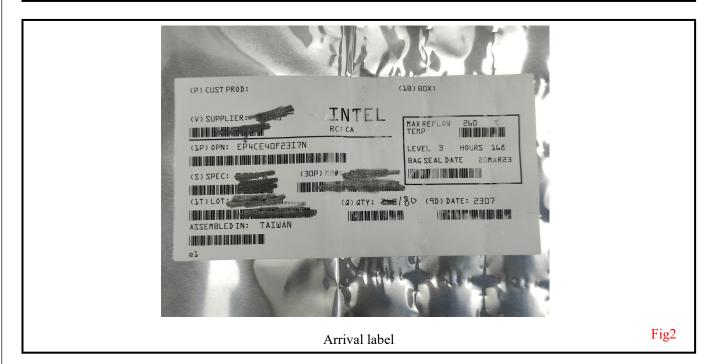
Fig1

Labels are clear, no alterations, label information checks out; typed versions, typography, etc. conform to original factory characteristics.

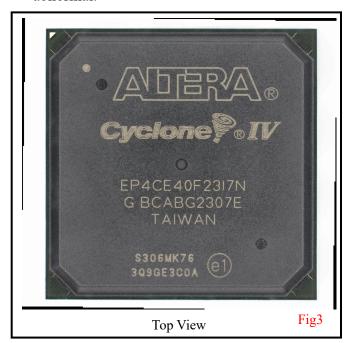
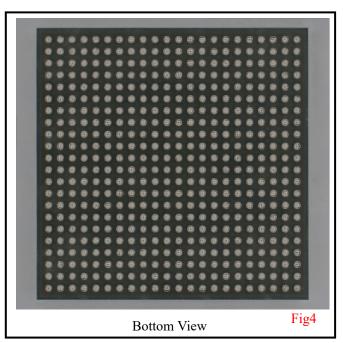
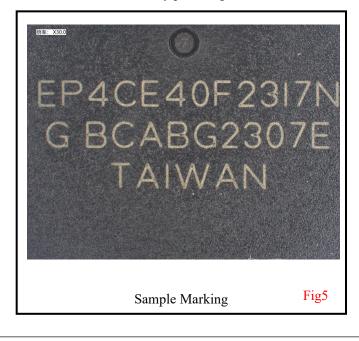
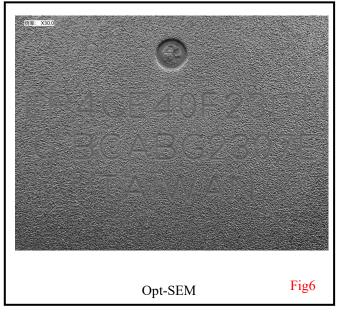
Marking, typing version, typesetting and other comparison is consistent, chip packaging is not abnormal.

The marking on the surface of the sample is clear, the granularity is obvious, the shape of the marking is regular, and there is no trace of secondary polishing;

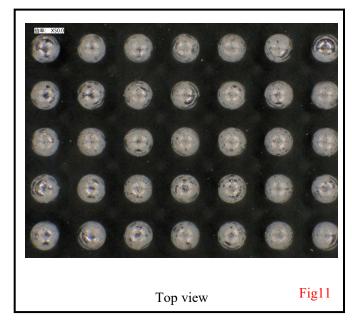
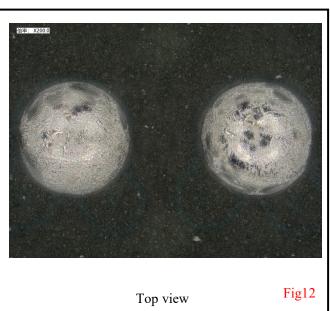
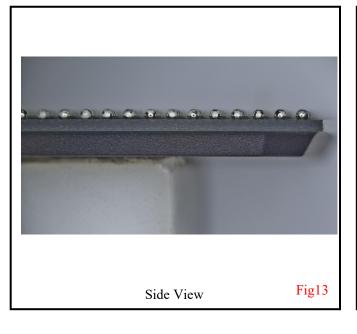
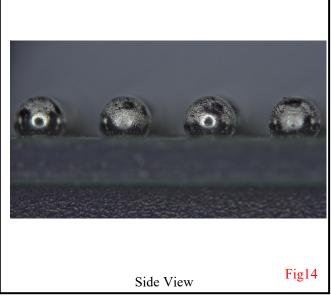
The diameter and height of the solder balls are in accordance with the specifications of the specification; Check the appearance of the solder balls one by one, there is no abnormality such as deformation and discoloration, the welding is good.

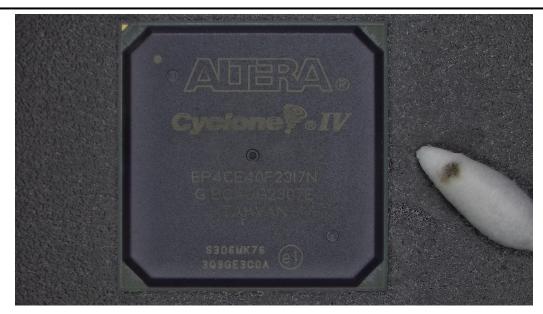
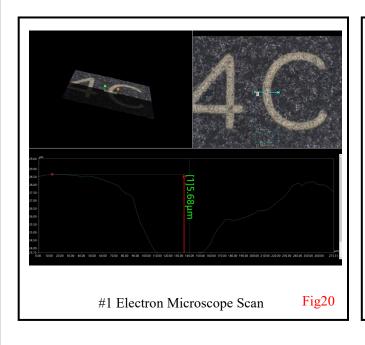
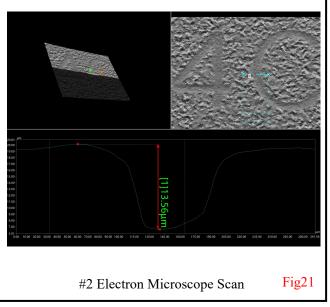
Acetone Test Fig19

After the surface and side of the sample were wiped back and forth with acetone for 3 times, the mark was still clearly visible, there was no obvious secondary coating, the depth of the mark did not change significantly under the EMS(Electron Microscope Scan), and the cotton swab was not blackened and other abnormal phenomena.

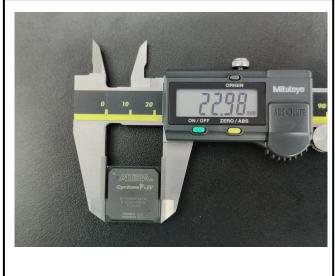
Fig22 Length: 22.98mm

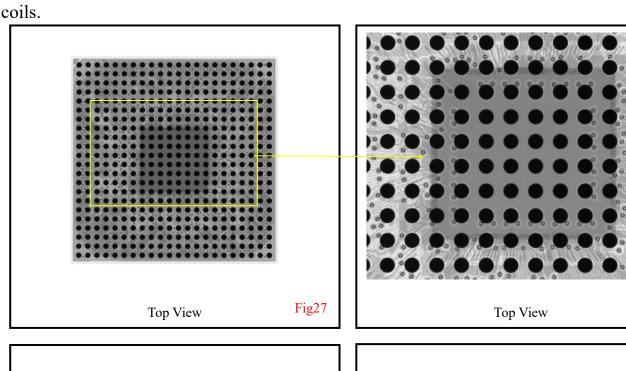
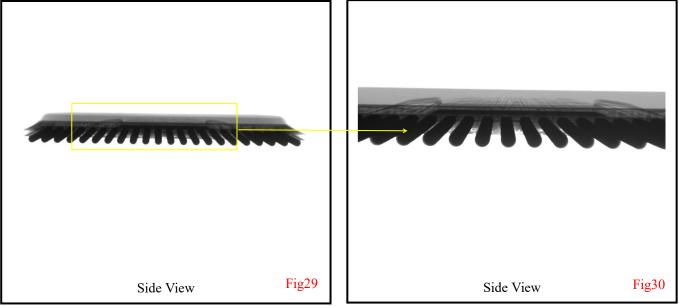
• X-RAY: The internal structure of the sample is intact, the interface at the output terminal well welded, there were no abnormalities such as broken wires or crossings in the inner coils.
