## Inspection Report

| Report No: | KHT-20250220-007 | Sales: | Wendy | Department Of Application | Sales |

| Sample Information | | | | | |
|---|---|---|---|---|---|
| Part Number: | RTL8305SC-LF | Package Type: | QFP128 | D/C: | 24+ |

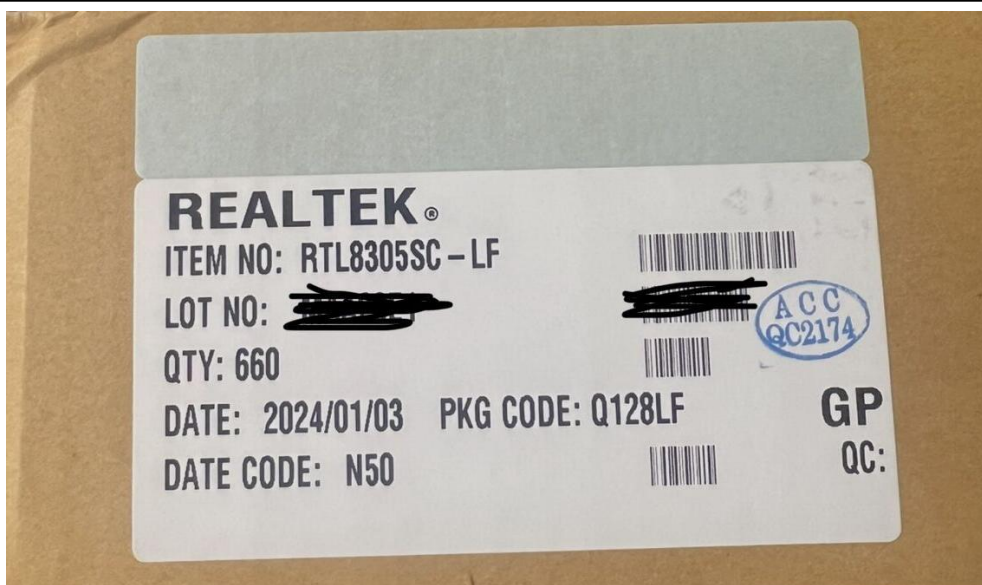
Fig2

Labels are clear, no alterations, label information checks out; typed versions, typography, etc. conform to original factory characteristics.

Arrival label

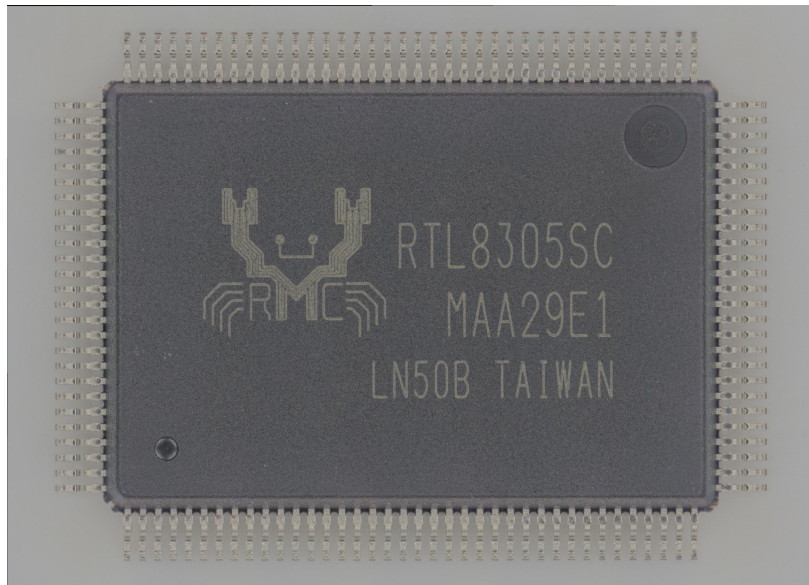
Fig3

Marking , typing version, typesetting and other comparison is consistent, chip packaging is not abnormal.

Top view

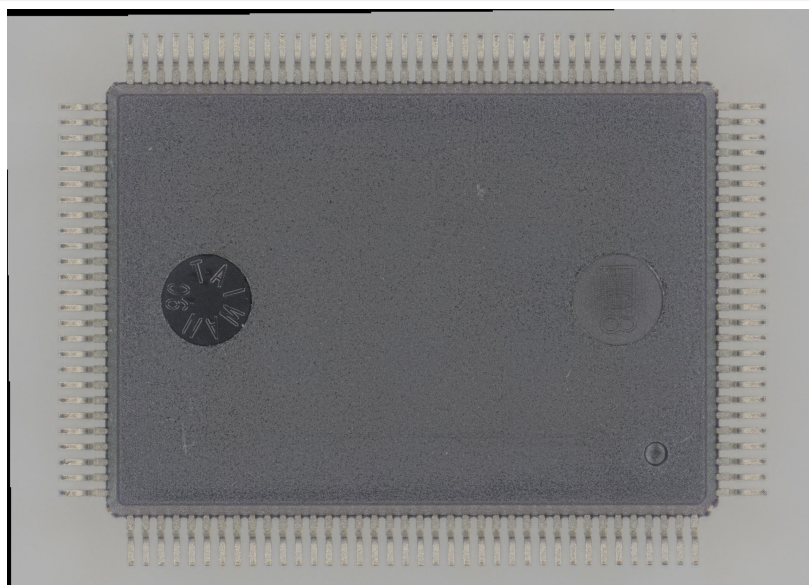
Fig4

Bottom view

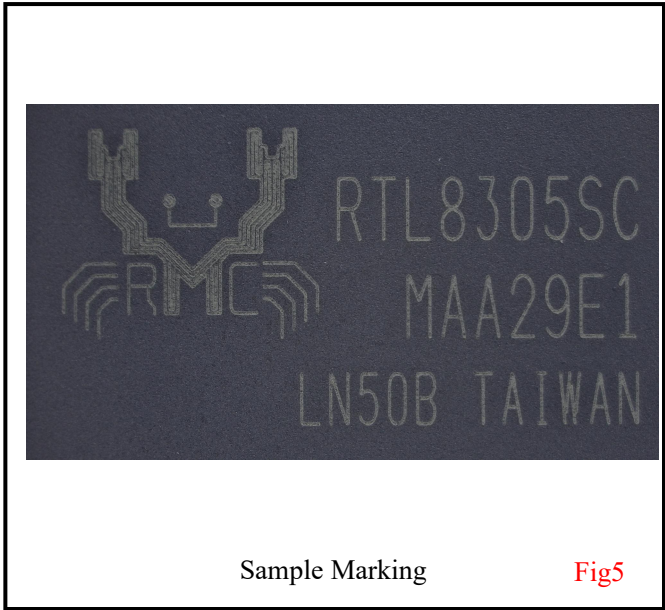
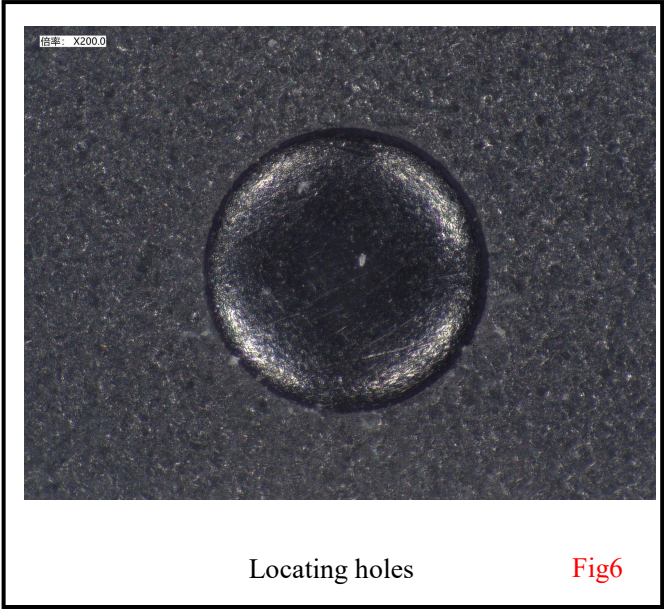
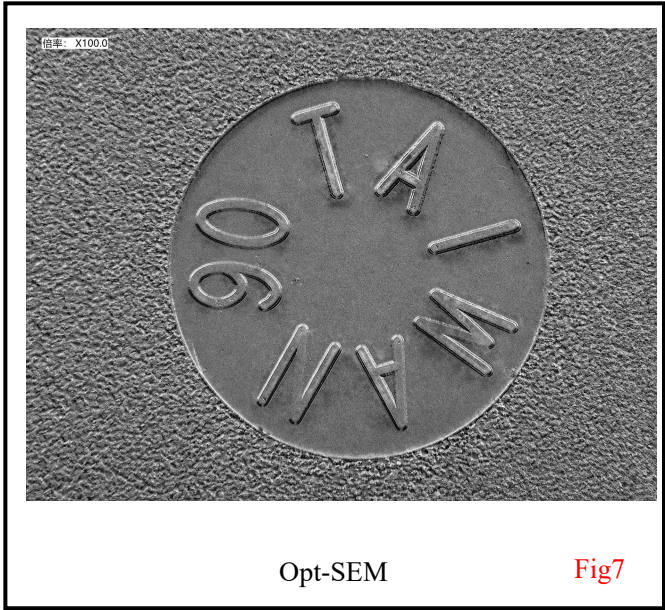
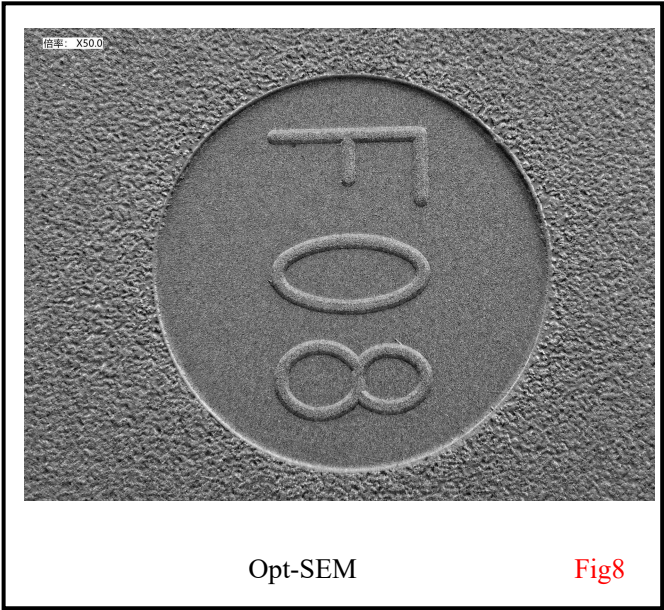
The marking on the surface of the sample is clear, the granularity is obvious, the shape of the marking is regular, and there is no trace of secondary polishing;

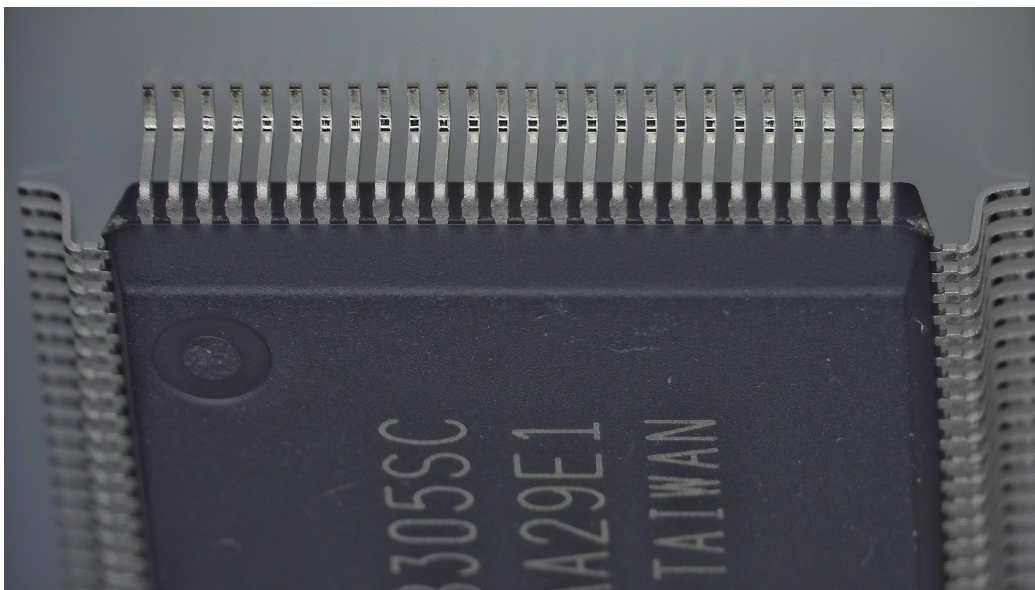
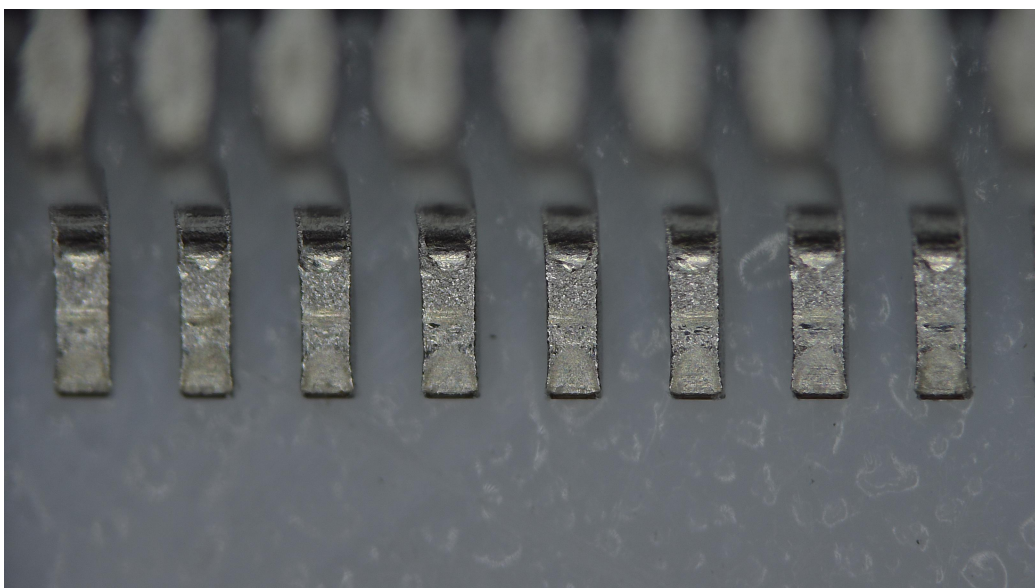
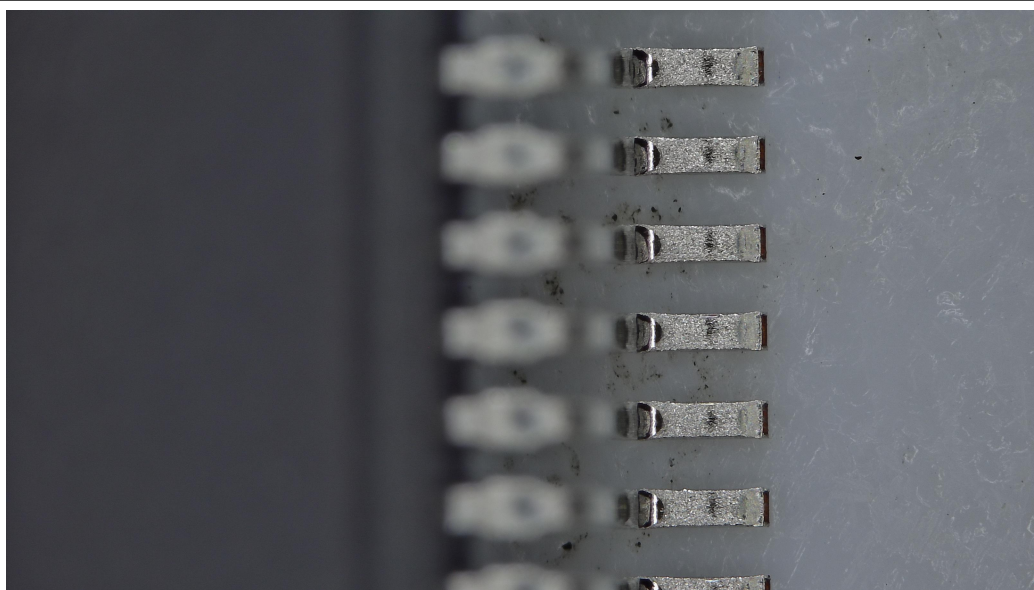
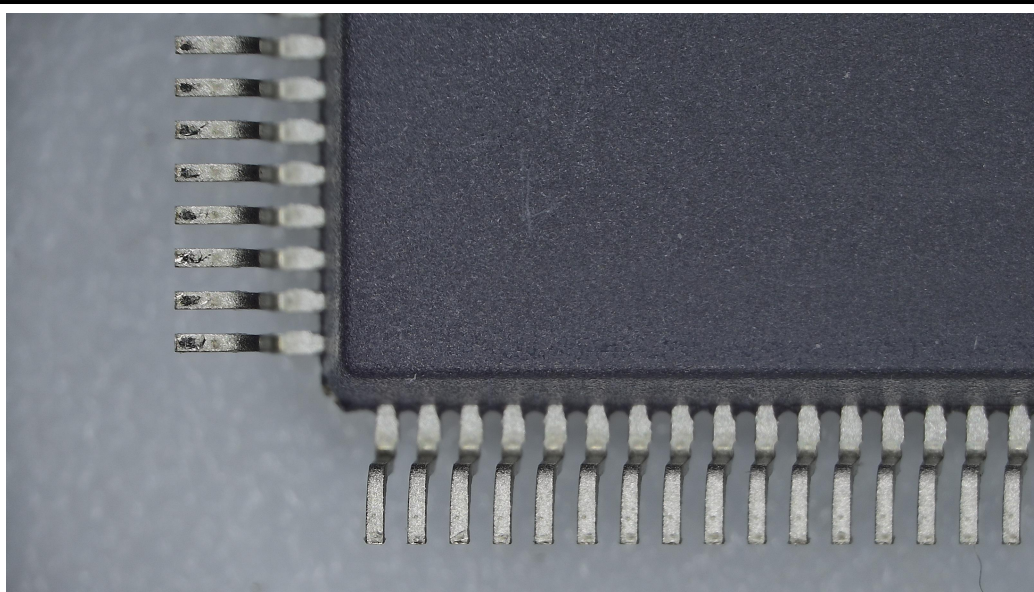
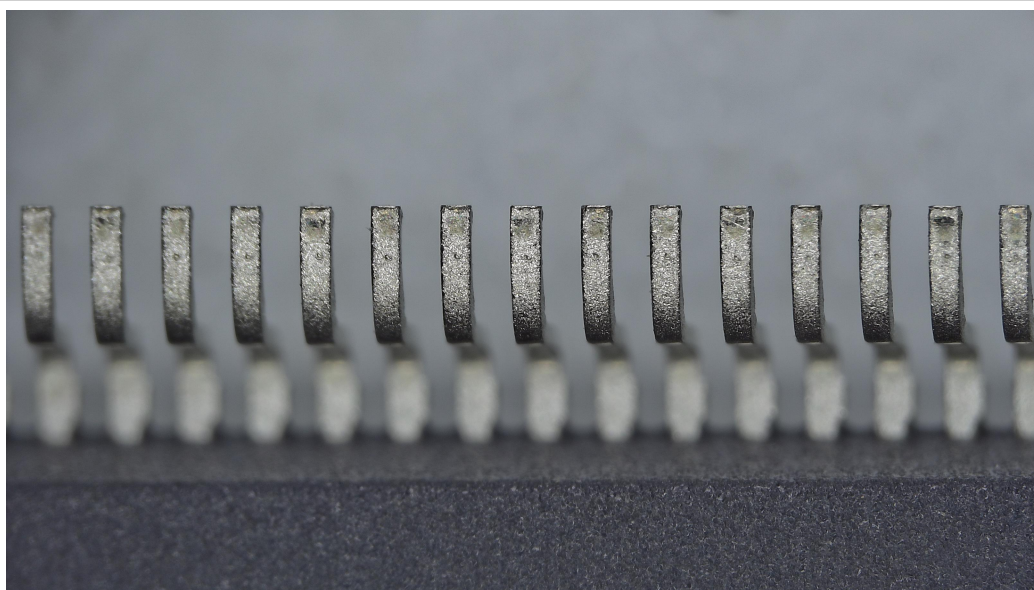
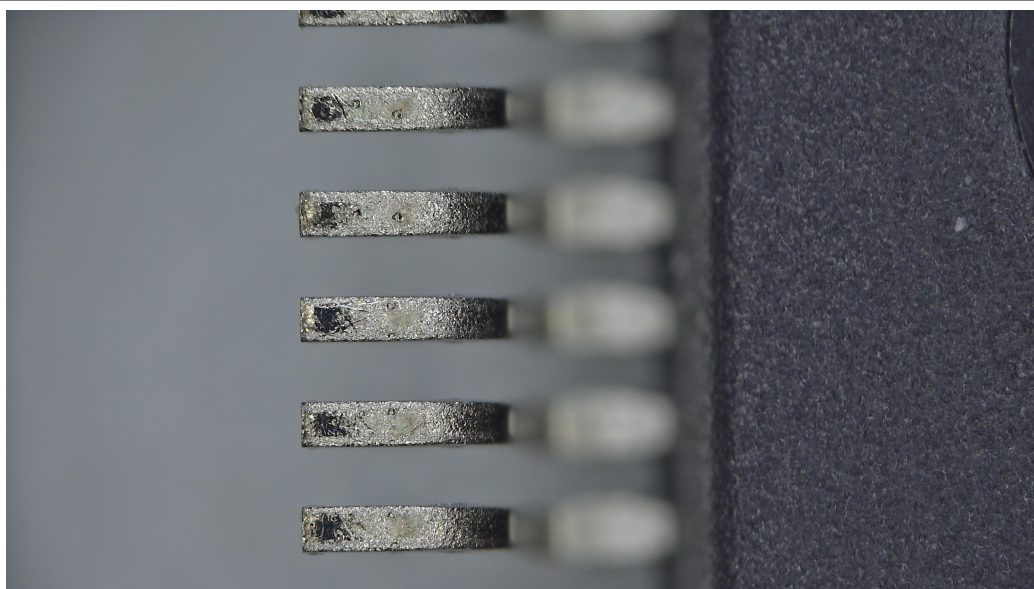
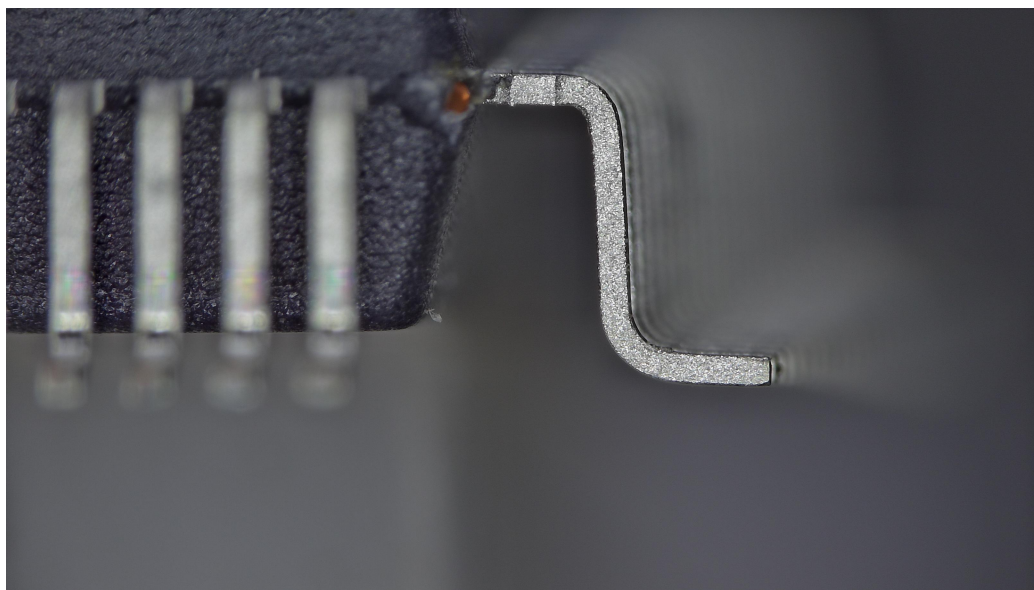
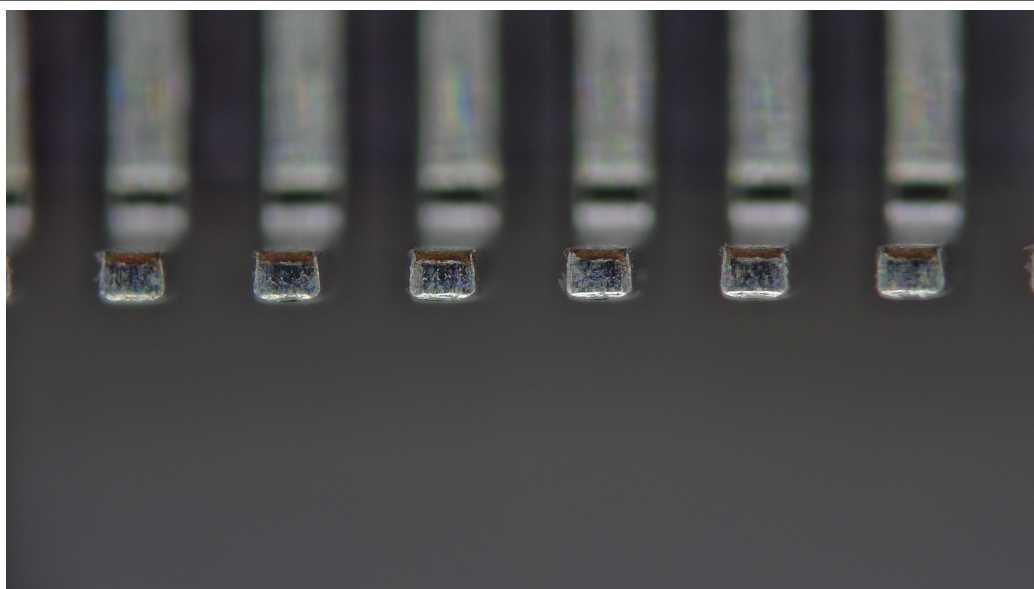
The tin on the pin is uniform without abnormal, the cross-section of the exposed copper substrate is a normal phenomenon, there is no obvious sanding characteristics, the overall condition is good.

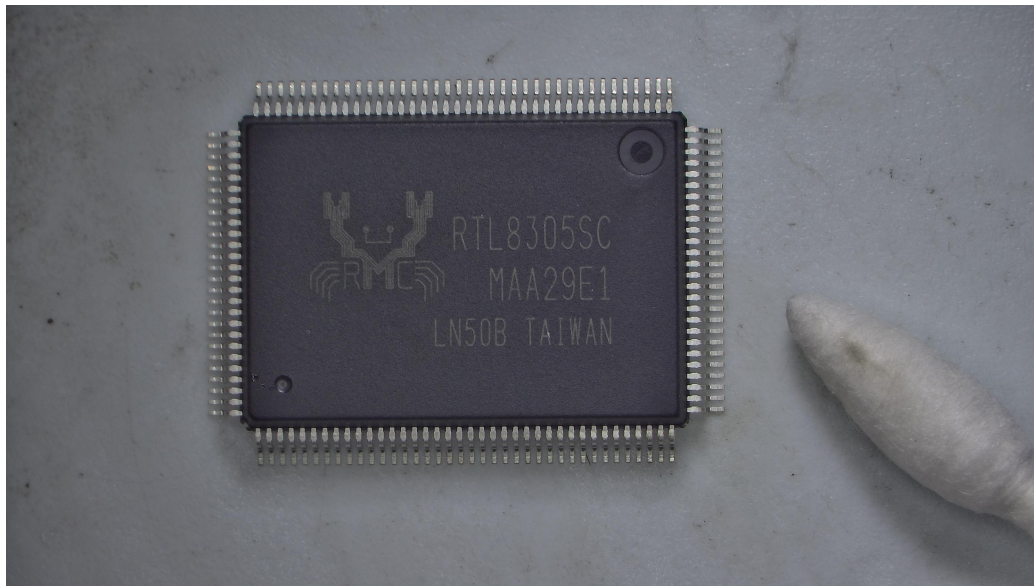
Fig17

After the surface and side of the sample were wiped back and forth with acetone for 3 times, the mark was still clearly visible, there was no obvious secondary coating, the depth of the mark did not change significantly under the EMS(Electron Microscope Scan),and the cotton swab was not blackened and other abnormal phenomena.

Acetone Test

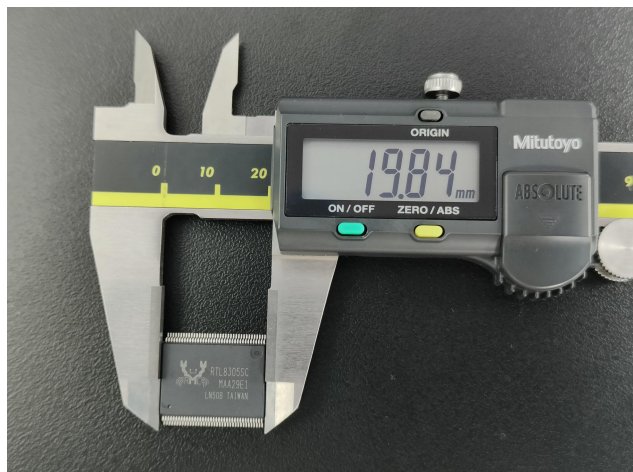
Fig20

- All size of the samples meet the requirement of the specifications.

Length: 19.84mm

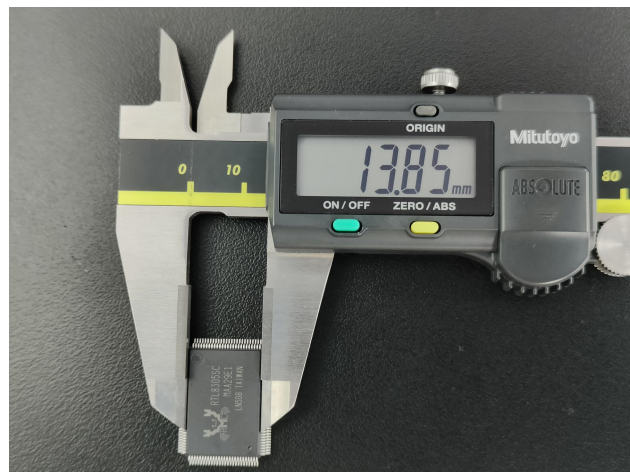
Fig21

Width: 13.85mm

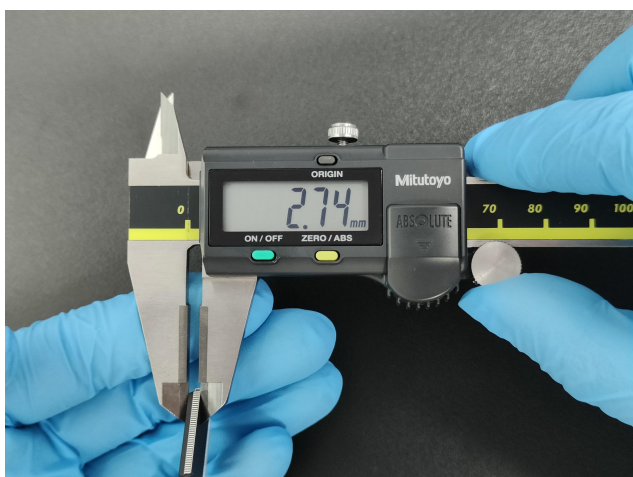
Fig22

Thicknesses: 2.74mm

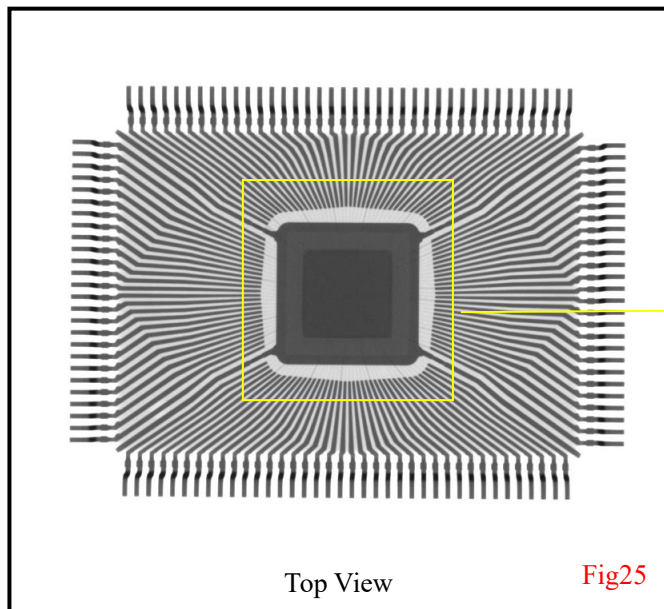
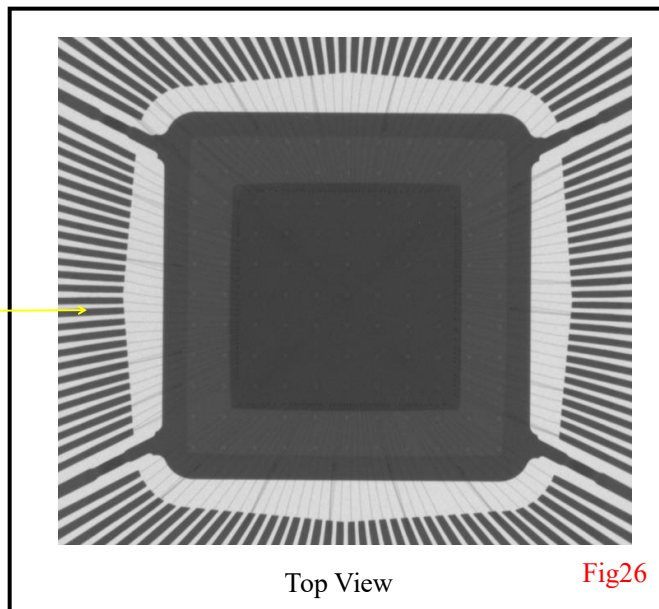
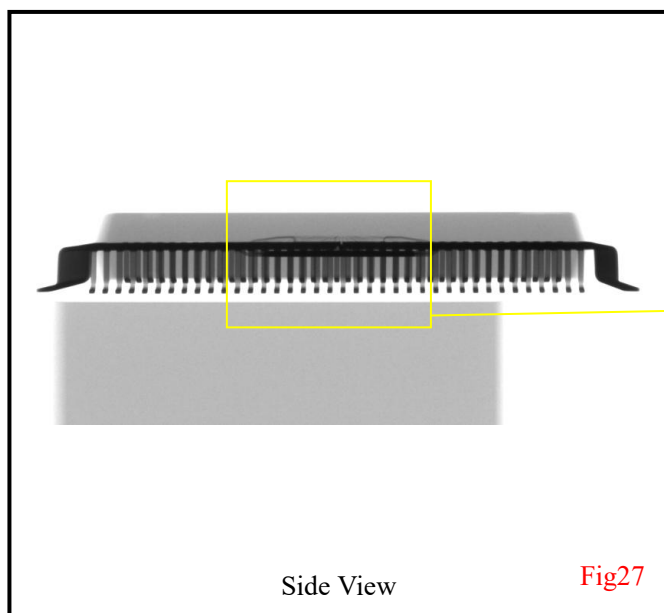
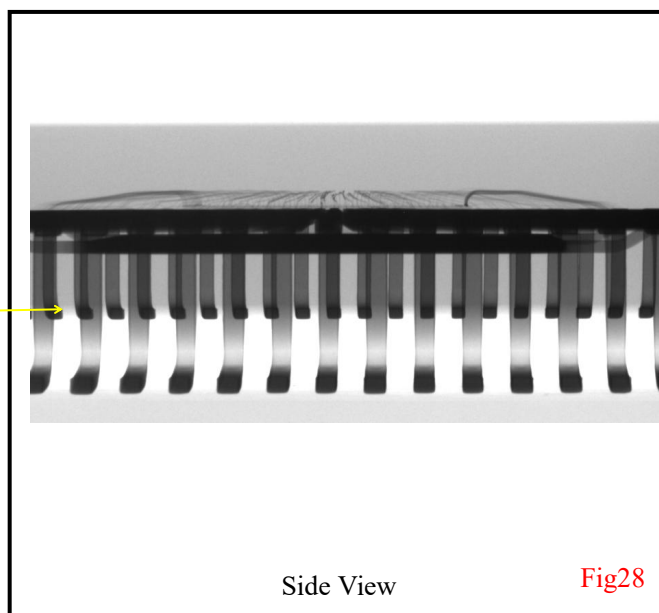
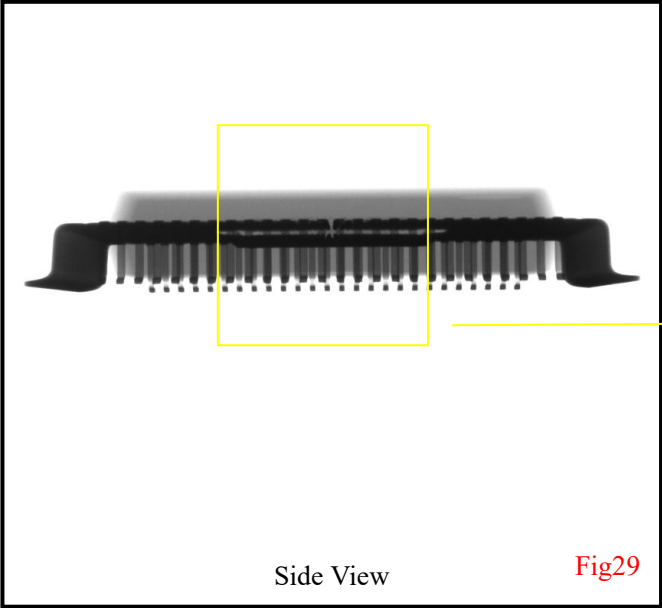
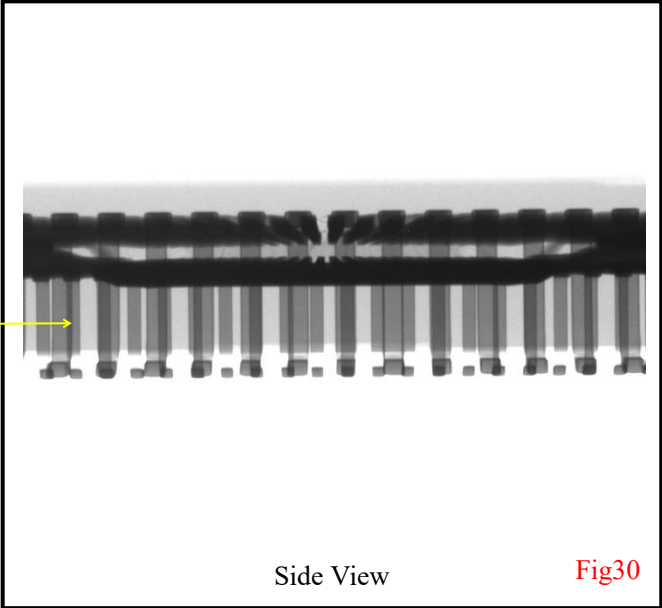
- X-RAY: Test does not reveal any abnormal inside the chips

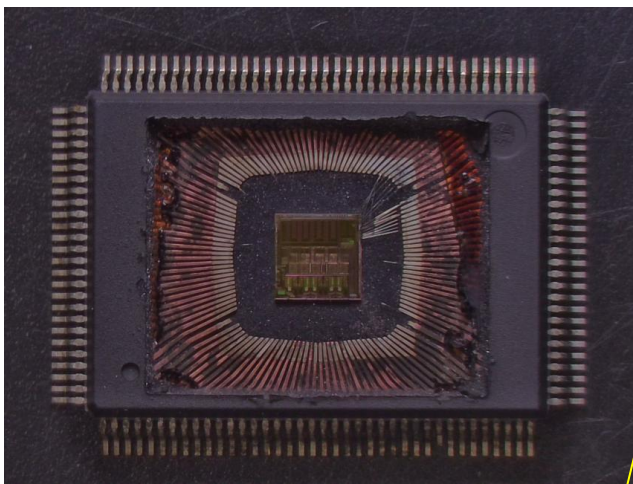
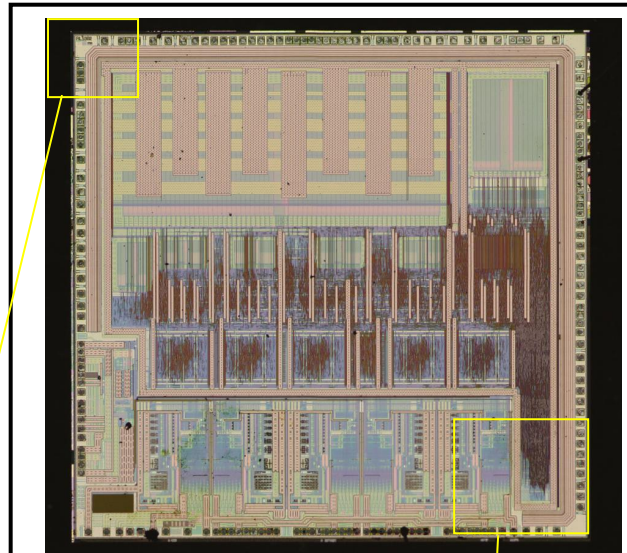
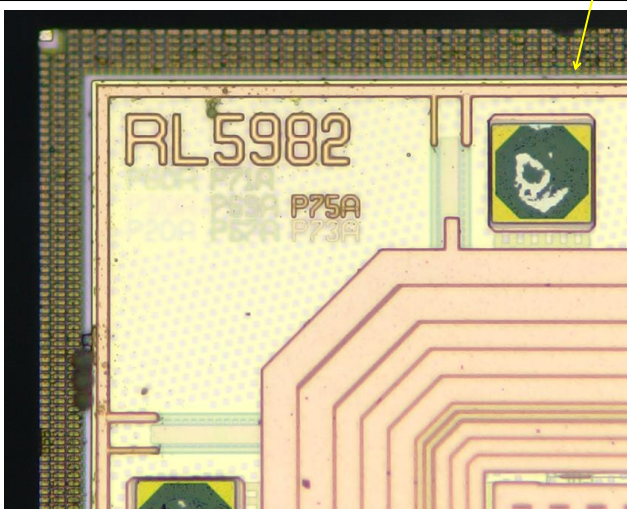
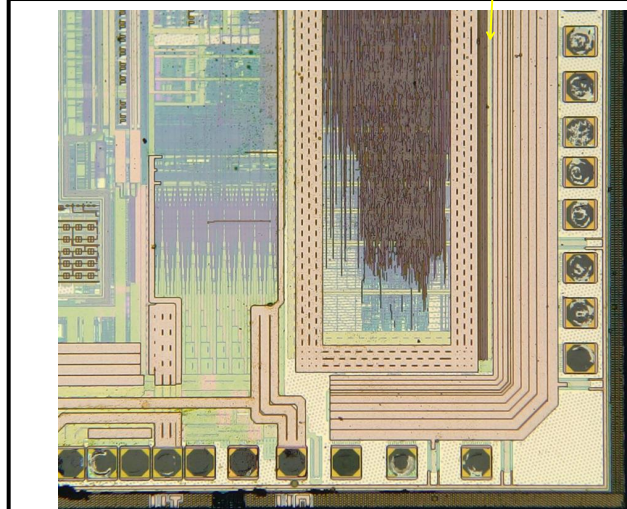
• De-cap die analysis according to the standard , After opening the die, it was found that the internal structure was complete , The inside of the wafer displays information such as "RL5982" and "P75A" , It is judged to be made by the original factory.
