Inspection Report

| Report No: | KHT-20250220-007 | Sales: | Wendy | Department Of Application | Sales |

| Sample Information | | | | | |
|---|---|---|---|---|---|
| Part Number: | RTL8305SC-LF | Package Type: | QFP128 | D/C: | 24+ |

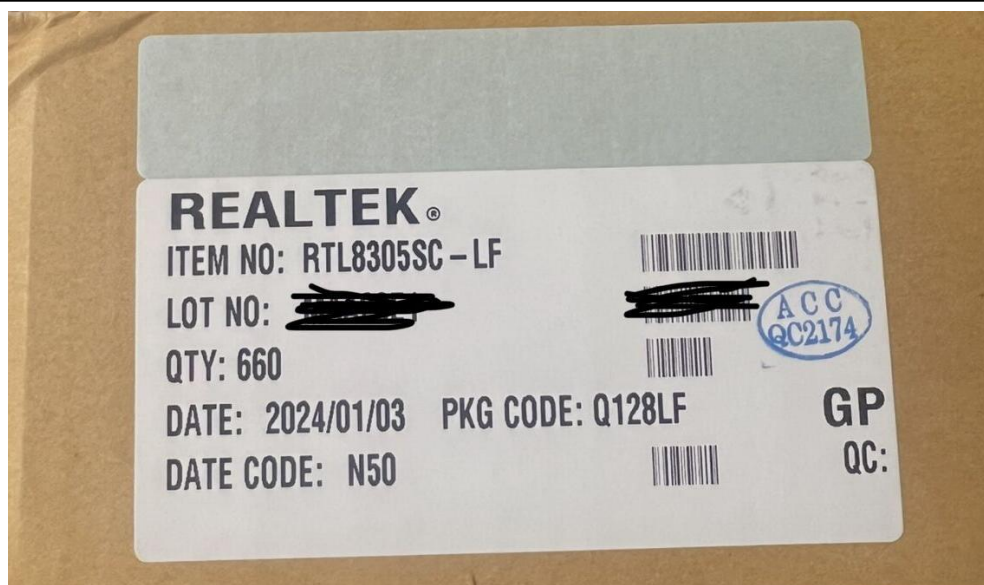
Fig2

Labels are clear, no alterations, label information checks out; typed versions, typography, etc. conform to original factory characteristics.

Arrival label

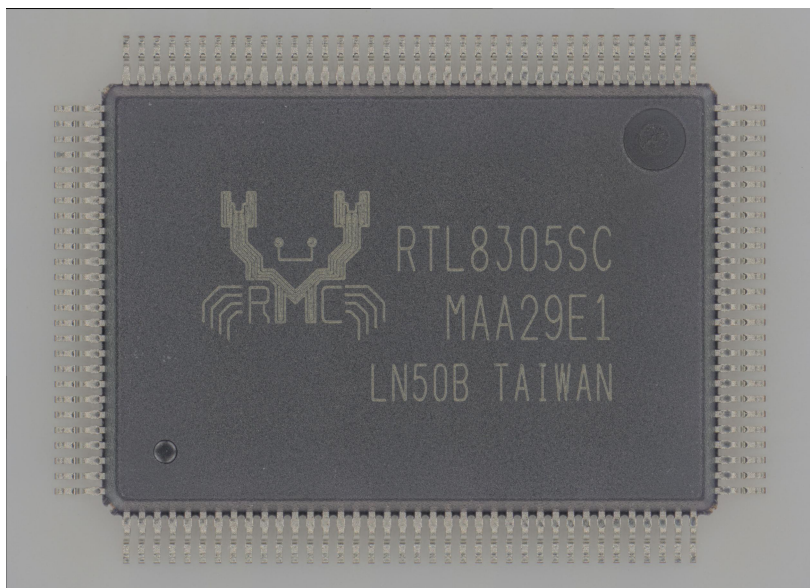
Fig3

Marking , typing version, typesetting and other comparison is consistent, chip packaging is not abnormal.

Top view

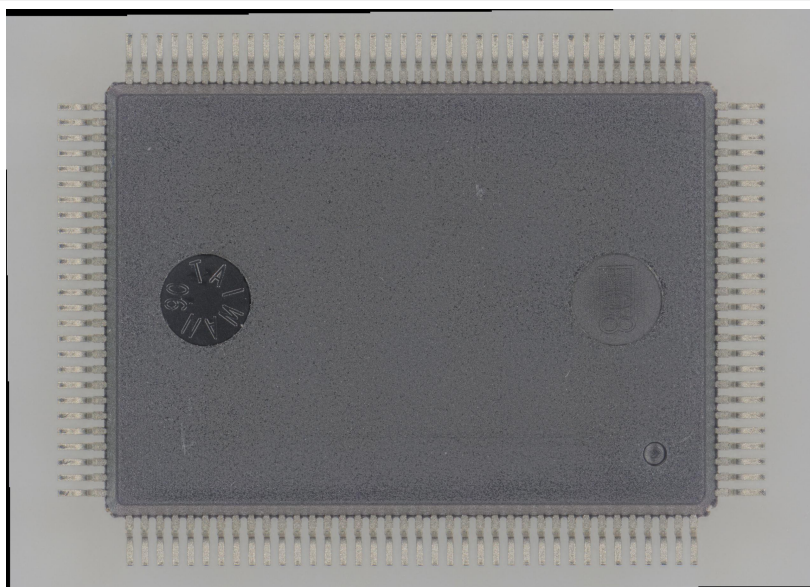
Fig4

Bottom view

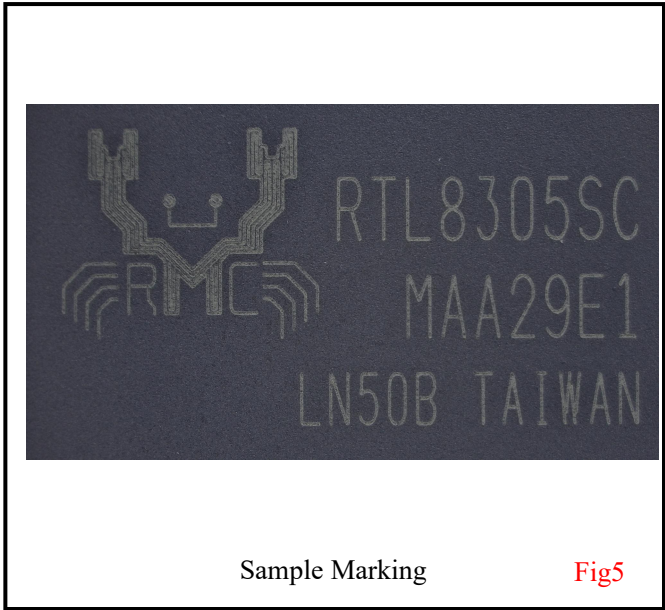
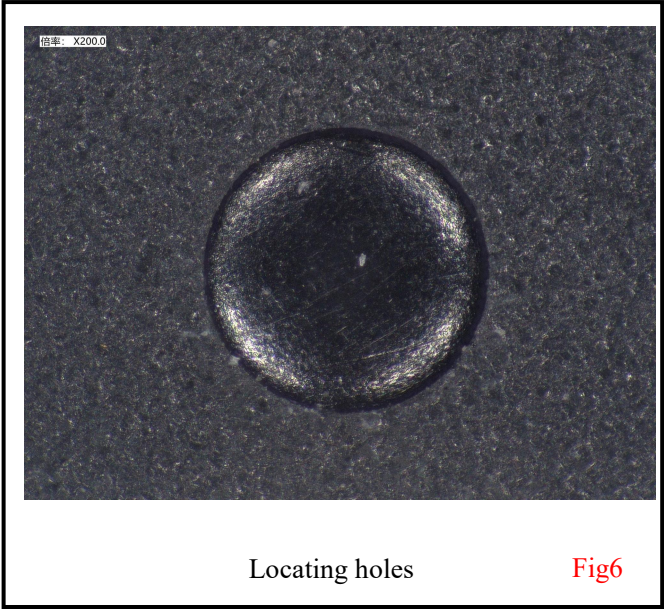
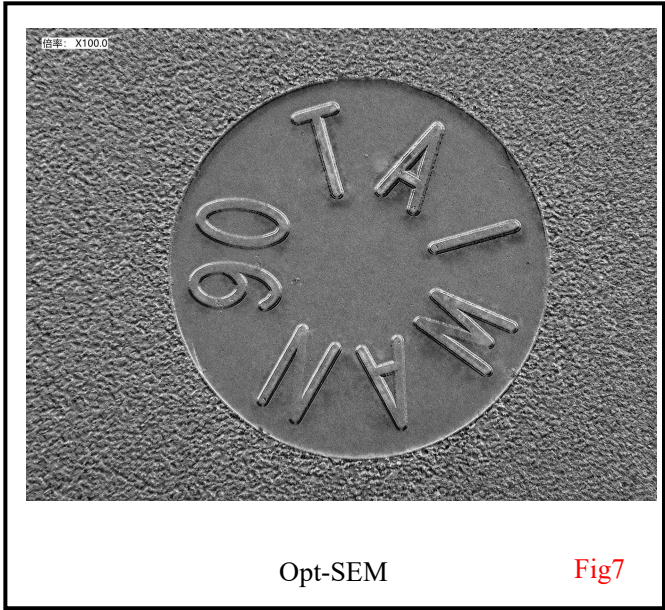
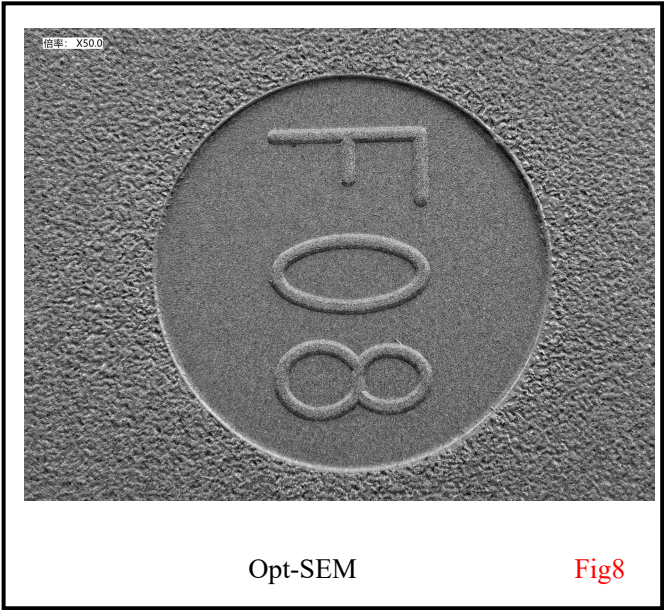
The marking on the surface of the sample is clear, the granularity is obvious, the shape of the marking is regular, and there is no trace of secondary polishing;

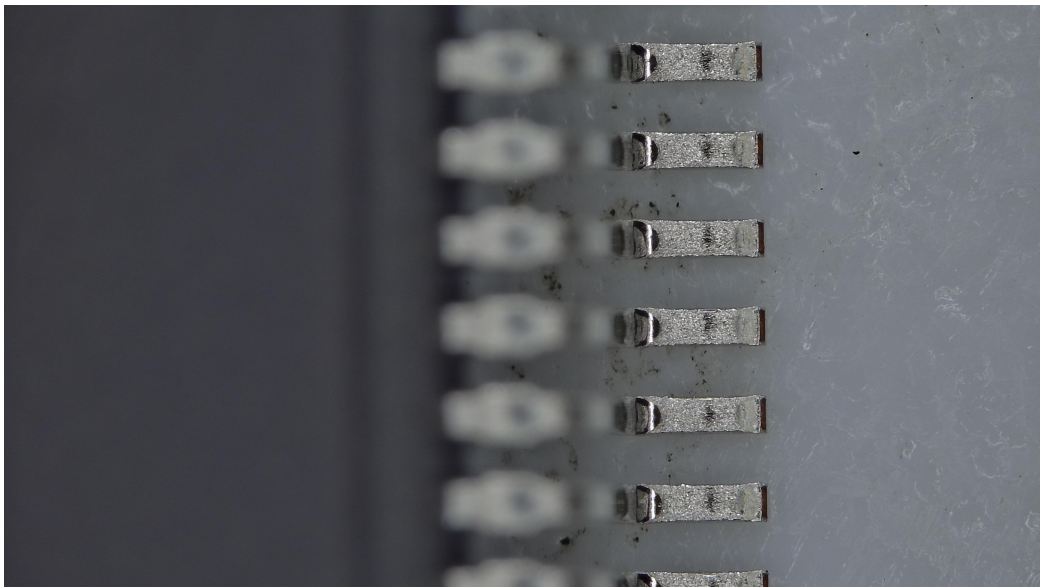
Fig11

The tin on the pin is uniform without abnormal, the cross-section of the exposed copper substrate is a normal phenomenon, there is no obvious sanding characteristics, the overall condition is good.

Top view

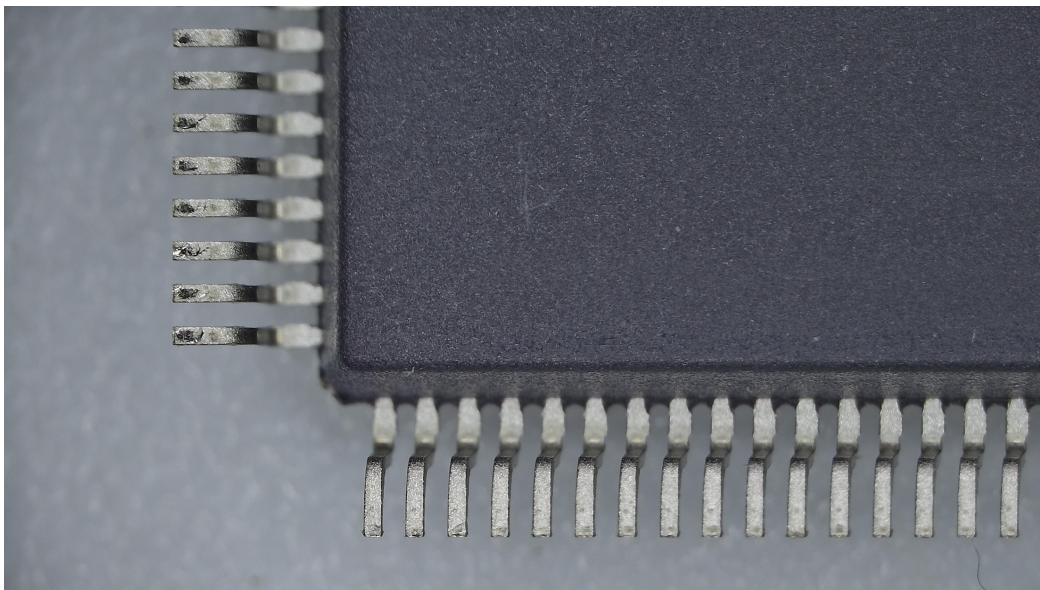
Fig12

Bottom view

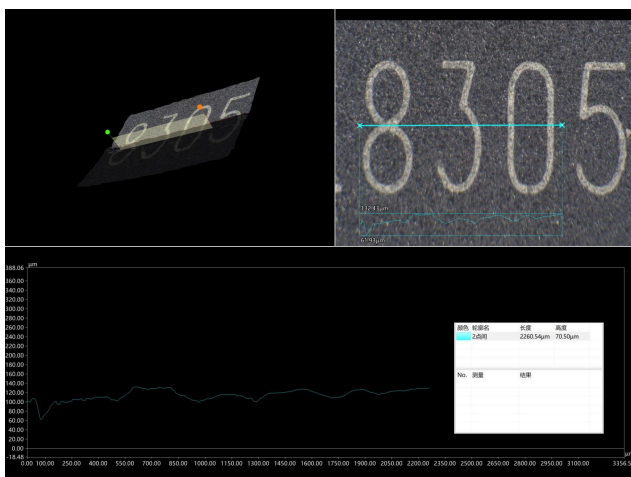
Fig18

After the surface and side of the sample were wiped back and forth with acetone for 3 times, the mark was still clearly visible, there was no obvious secondary coating, the depth of the mark did not change significantly under the EMS(Electron Microscope Scan),and the cotton swab was not blackened and other abnormal phenomena.

#1 Electron Microscope Scan

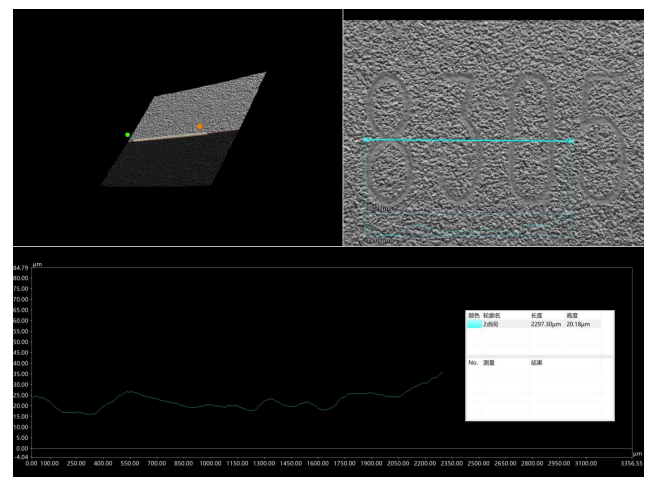
Fig19

#2 Electron Microscope Scan

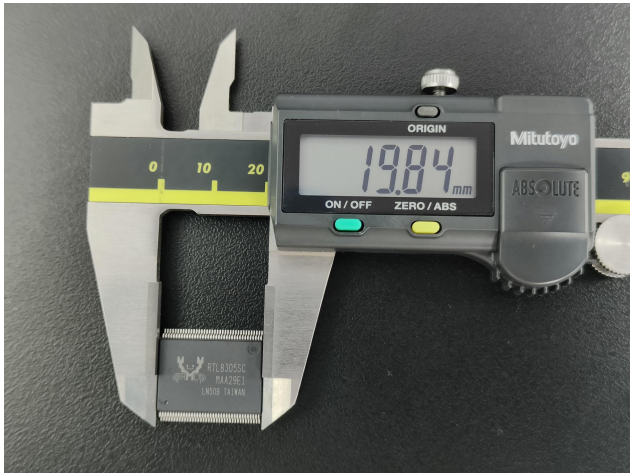
Fig20

Length: 19.84mm

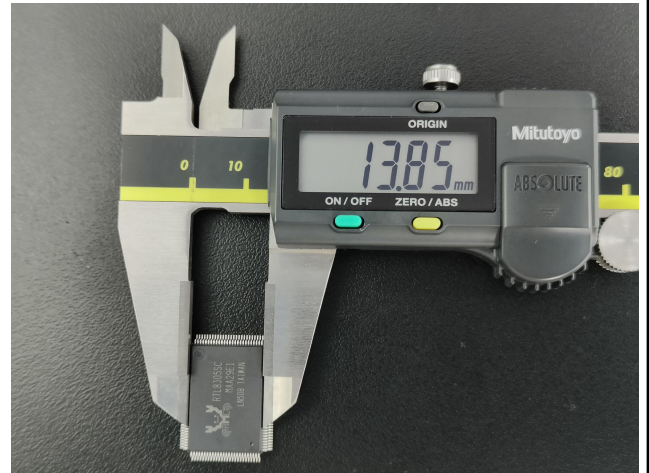
Fig21

Width: 13.85mm

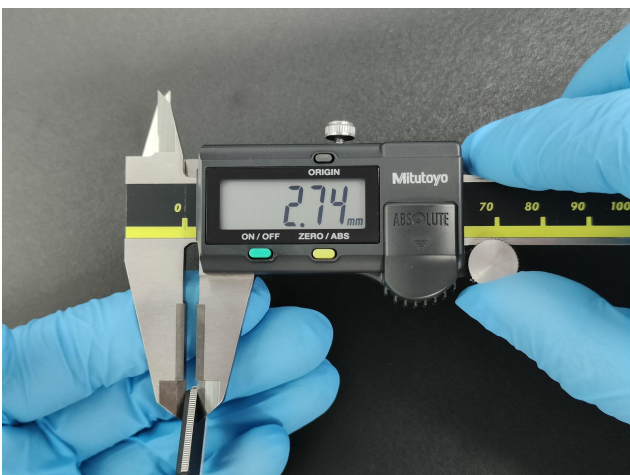
Fig22

Thicknesses: 2.74mm

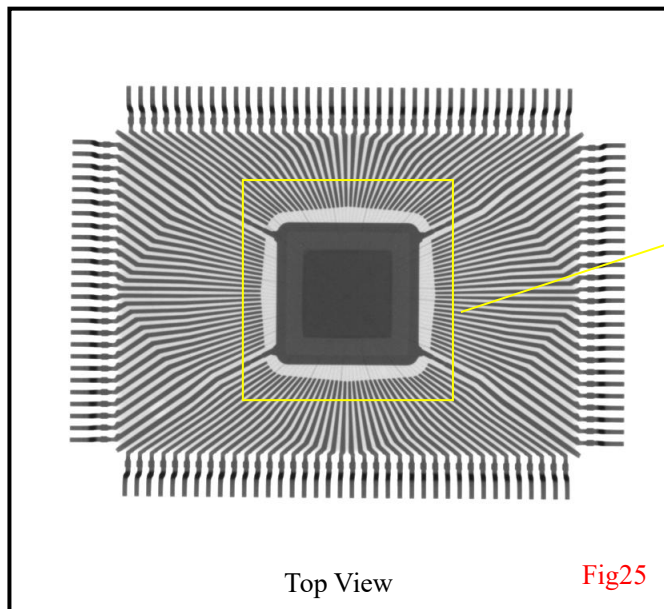
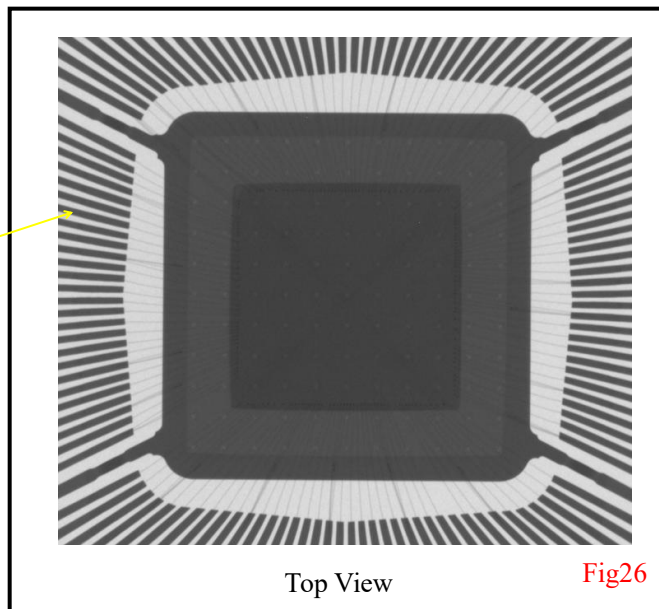
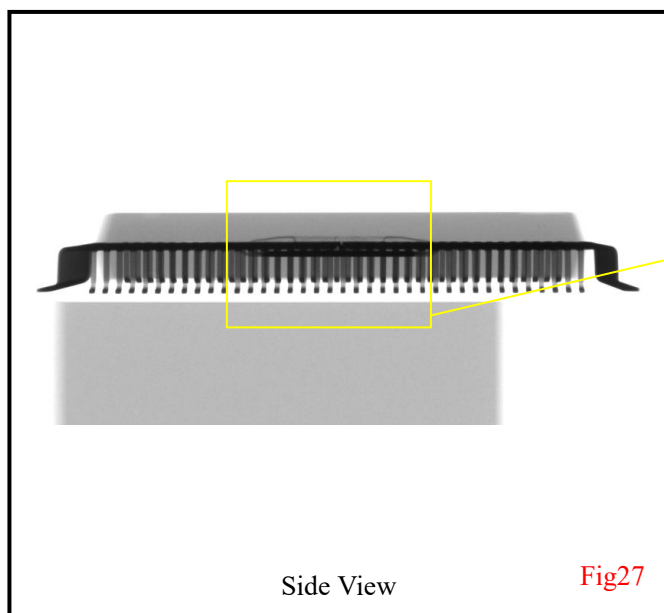
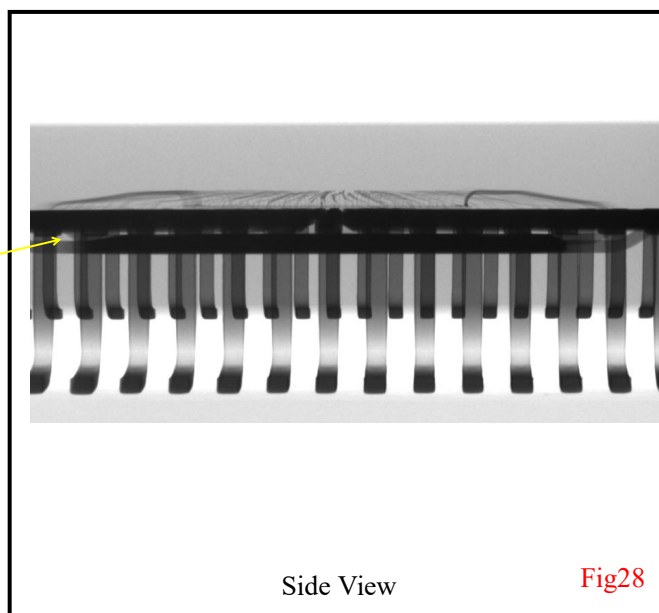
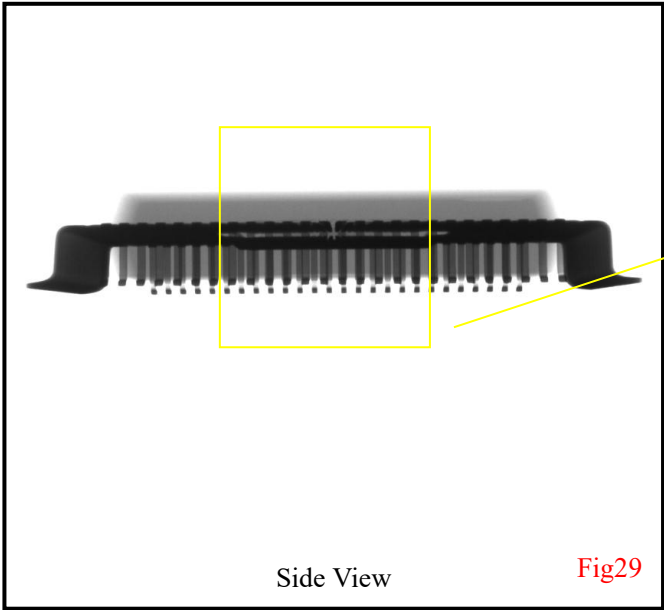
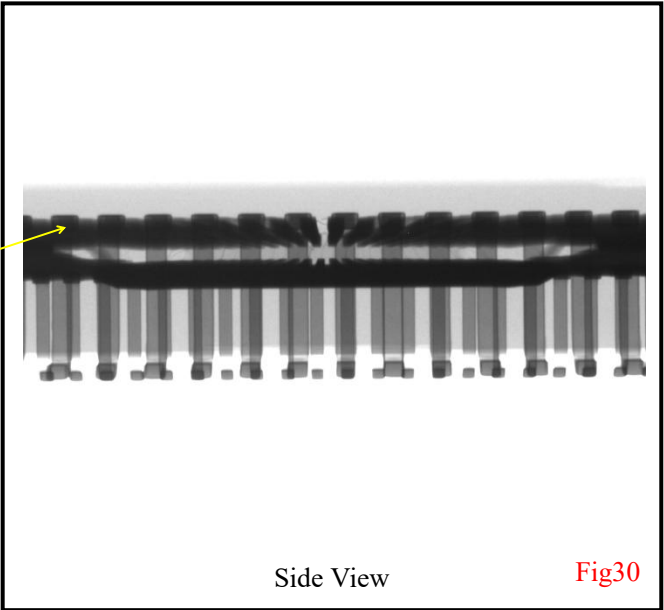
- X-RAY: Test does not reveal any abnormal inside the chips

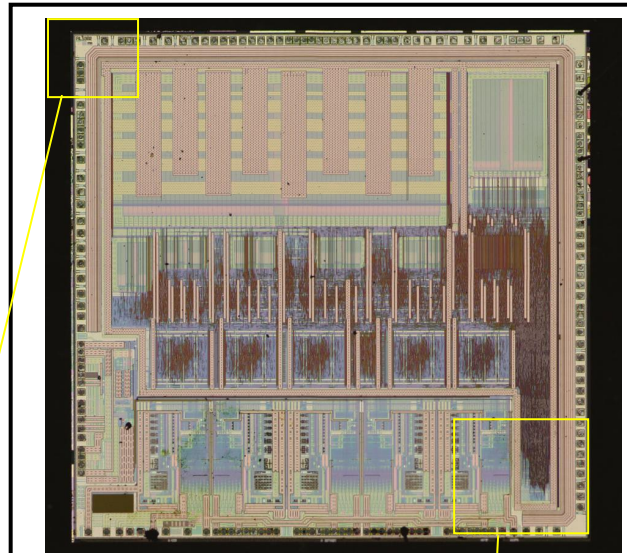
Fig32

• De-cap die analysis according to the standard , After opening the die, it was found that the internal structure was complete , The inside of the wafer displays information such as "RL5982" and "P75A" , It is judged to be made by the original factory.

Die architecture

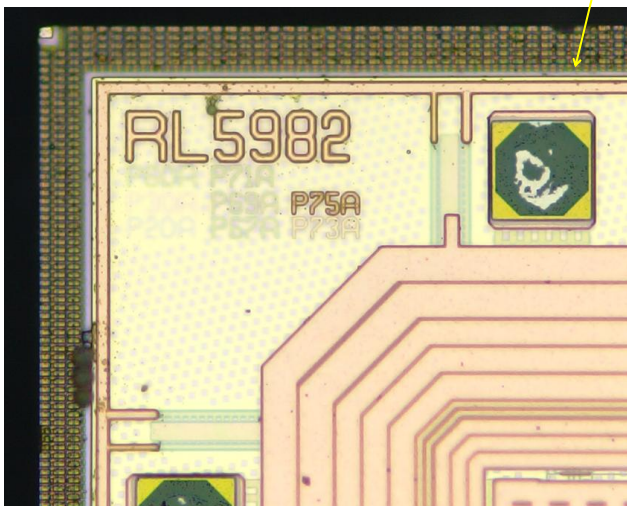
Fig33

Wafer

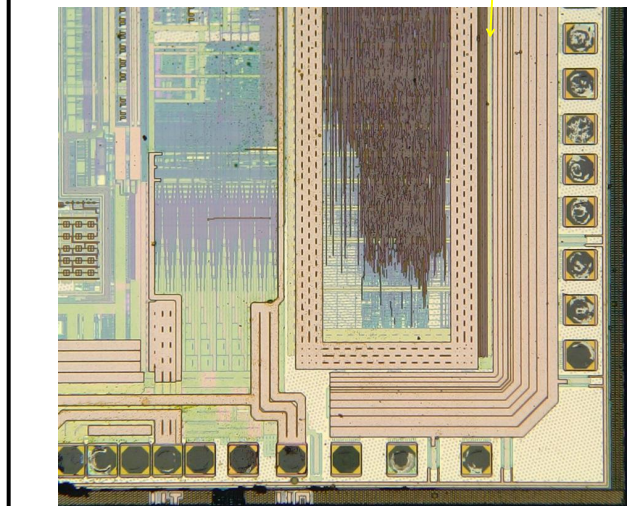
Fig34

Wafer
