Inspection Report

Report No:	KHT-20250327-033	Sales:	Daniel Yuan	Department Of Application	Sales
Receipt Date:	2025-03-05	Test Date:	2025-03-05	Report Date:	2025-03-27
Inspector:	周亚龙	Approved by:	黄浩泽	Approved by:	郭亚彬

Sample Information					
Part Number:	EP4CE40F23I7N	Package Type:	FBGA-484	D/C:	2307+
Package Carrier:	TRAY	Manufacturer:	ALTERA	MSL:	3
Quantity Received:	180pcs	Quantity Inspected:	5pcs	PO Number:	1215075524
Incoming information: The incoming goods for 1 box,240pcs / box, Vacuum-packed ; with original labels , but some of the information on the label is hidden.; There is no abnormality in the outer packaging.

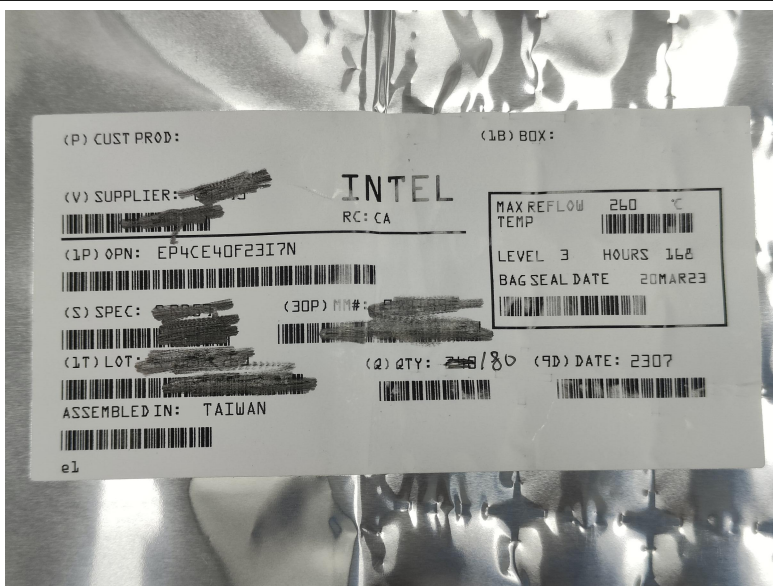
Fig2

Labels are clear, no alterations, label information checks out; typed versions, typography, etc. conform to original factory characteristics.

Arrival label

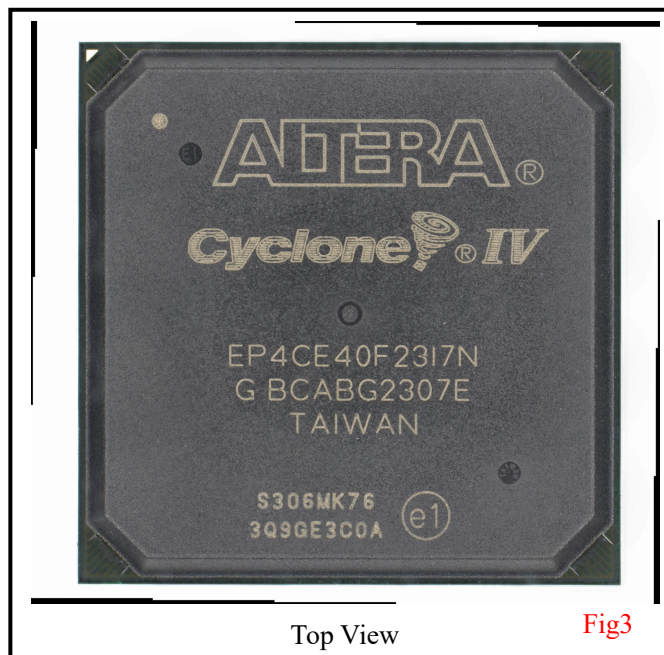
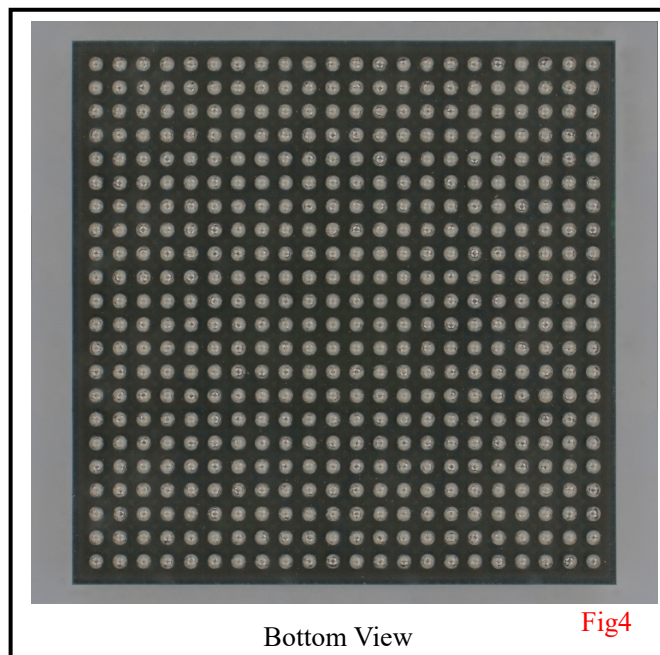
Marking , typing version, typesetting and other comparison is consistent, chip packaging is not abnormal.

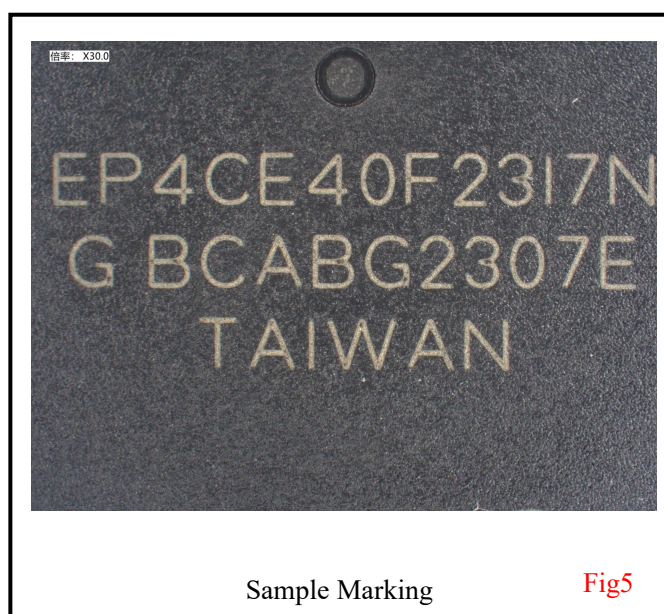
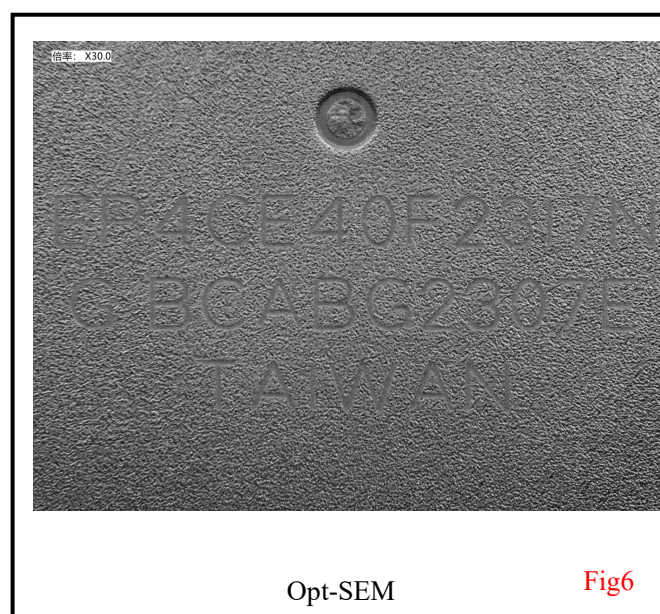
The marking on the surface of the sample is clear, the granularity is obvious, the shape of the marking is regular, and there is no trace of secondary polishing;

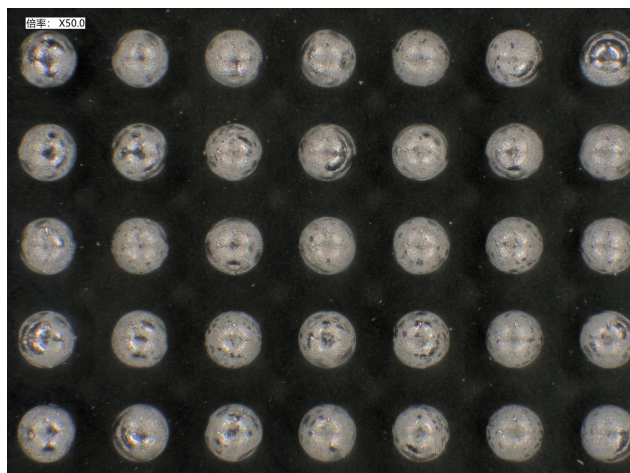
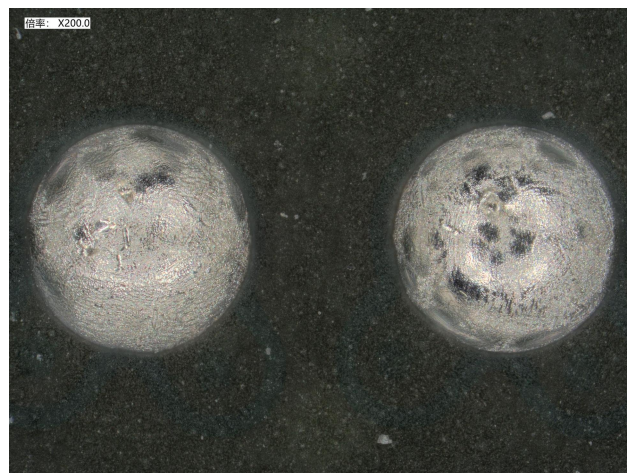
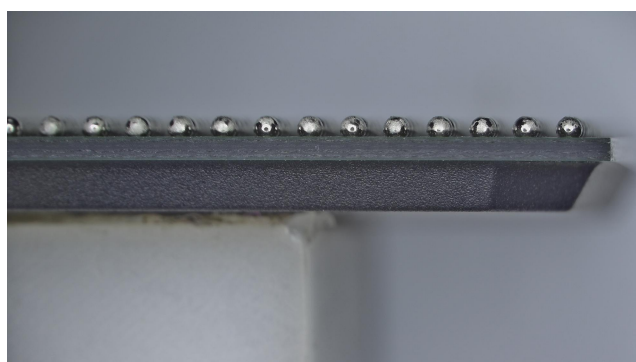
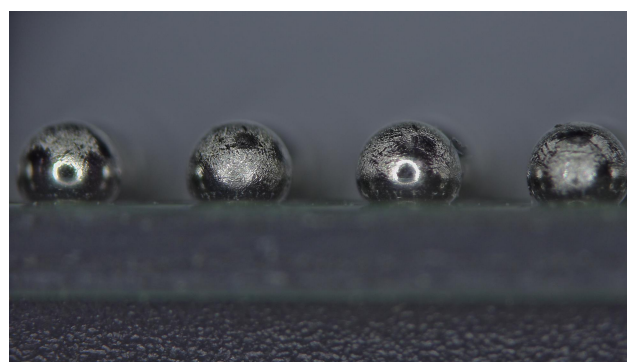
The diameter and height of the solder balls are in accordance with the specifications of the specification; Check the appearance of the solder balls one by one, there is no abnormality such as deformation and discoloration, the welding is good.

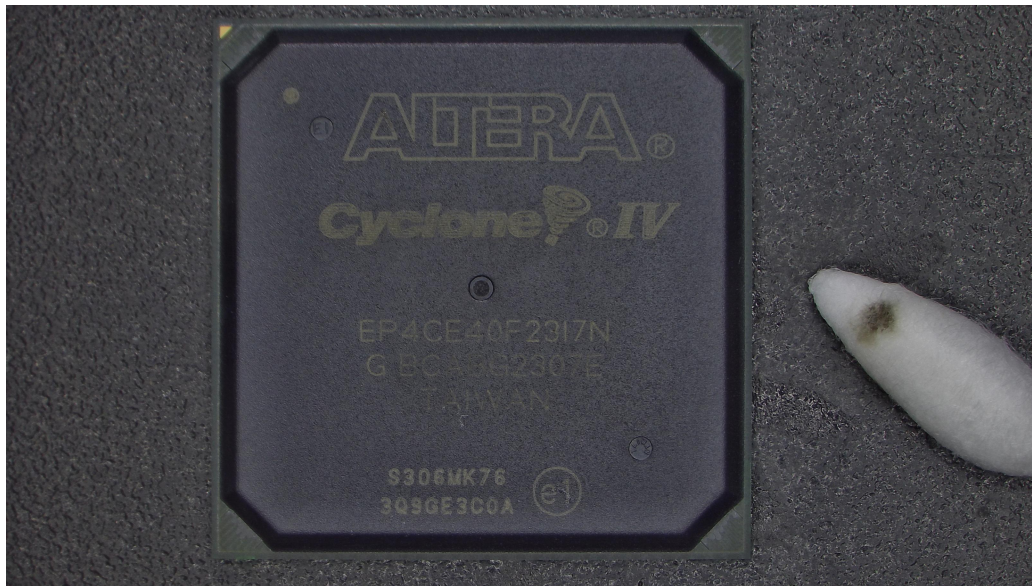
Fig19

After the surface and side of the sample were wiped back and forth with acetone for 3 times, the mark was still clearly visible, there was no obvious secondary coating, the depth of the mark did not change significantly under the EMS(Electron Microscope Scan),and the cotton swab was not blackened and other abnormal phenomena.

Acetone Test

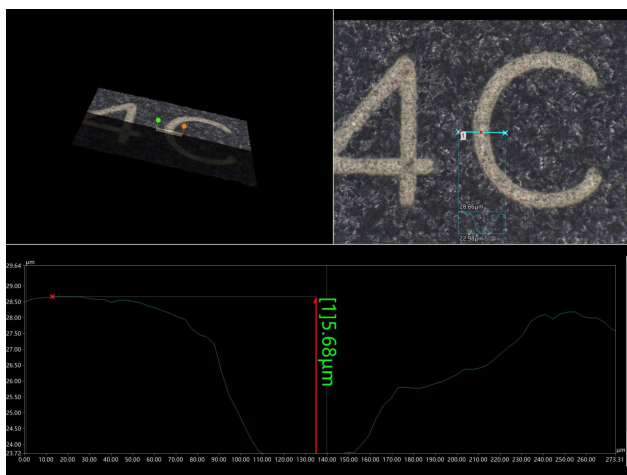
Fig20

#1 Electron Microscope Scan

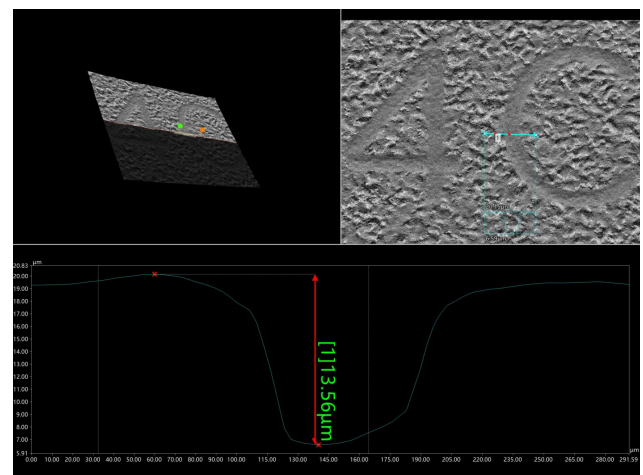
Fig21

#2 Electron Microscope Scan

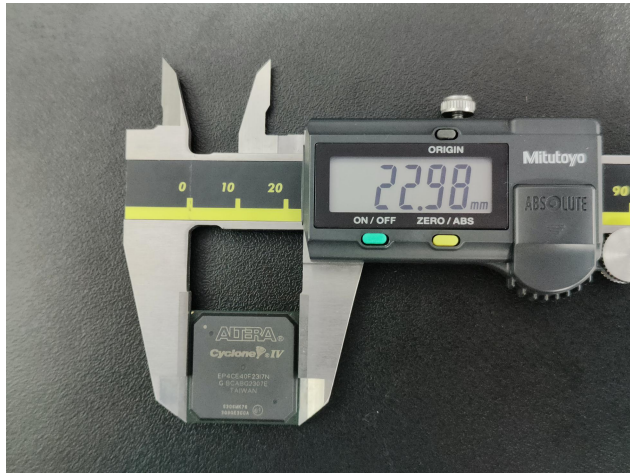
Fig22

- All size of the samples meet the requirement of the specifications.

Length: 22.98mm

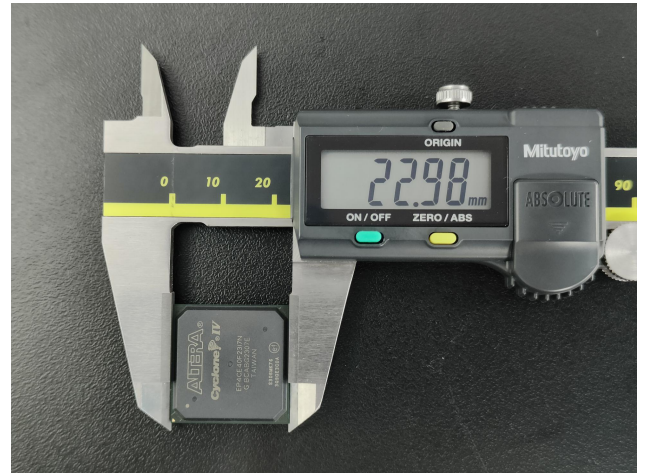
Fig23

Width: 22.98mm

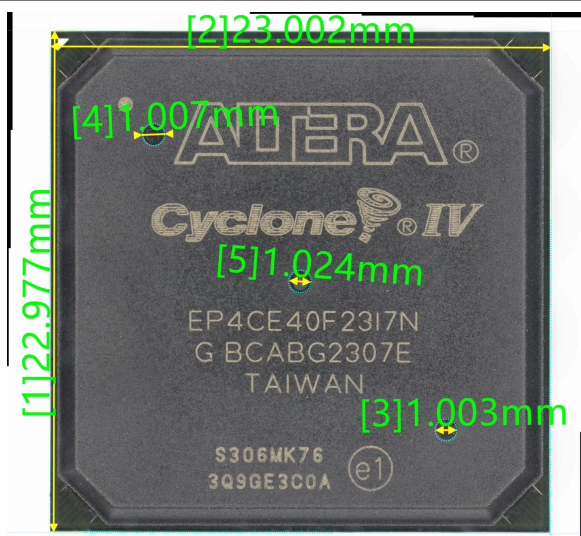
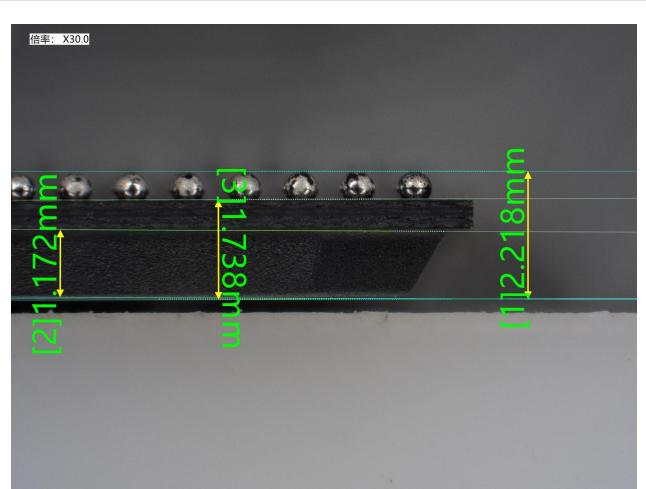
Sample number	Length/mm	Width/mm	Thicknesses/mm	Result
#1	22.98	22.98	1.74	PASS
#2	23.00	22.98	1.75	PASS
#3	22.99	22.99	1.74	PASS
#4	23.00	22.98	1.75	PASS
#5	22.98	23.00	1.76	PASS

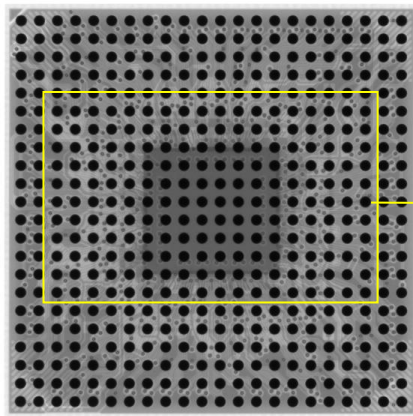
Fig27

• X-RAY: The internal structure of the sample is intact, the interface at the output terminal well welded, there were no abnormalities such as broken wires or crossings in the inner coils.
