Inspection Report

| Report No: | KHT-20250422-042 | Sales: | JAX | Department Of Application | Sales |

| Sample Information | | | | | |
|---|---|---|---|---|---|
| Part Number: | AOZ1280CI | Package Type: | SOT23 | D/C: | 25+ |

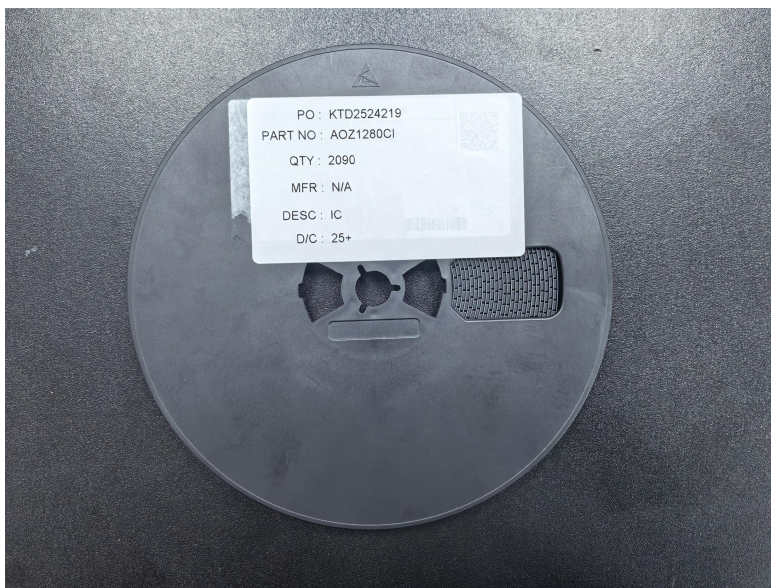
Fig1

Labels are clear, no alterations, label information checks out; typed versions, typography, etc. conform to original factory characteristics.

Arrival picture

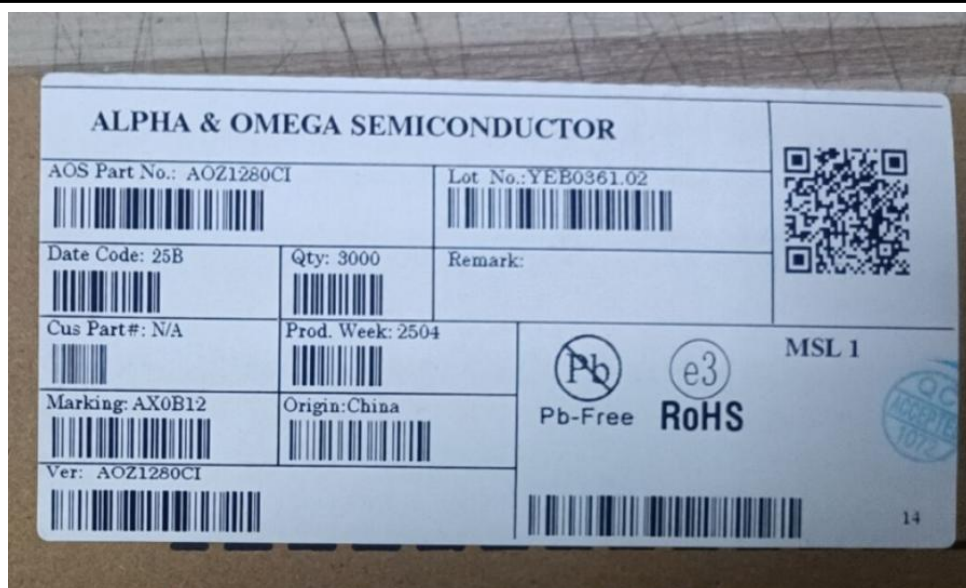
Fig2

Arrival label

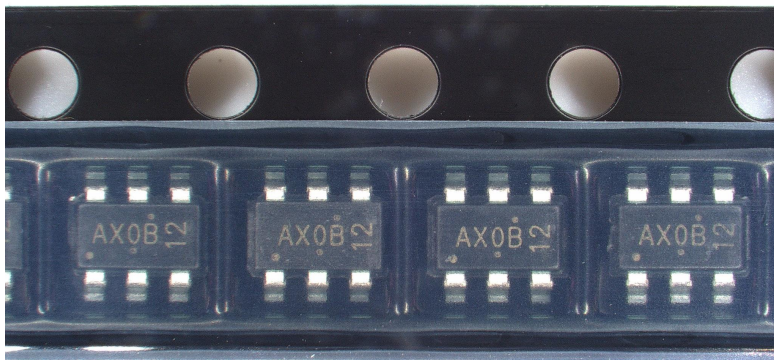
Fig3

The braided tape has no tears or burst tapes, meets the specifications of the specification, is a clear film with even indentations, and conforms to the original characteristics.

Tape Front

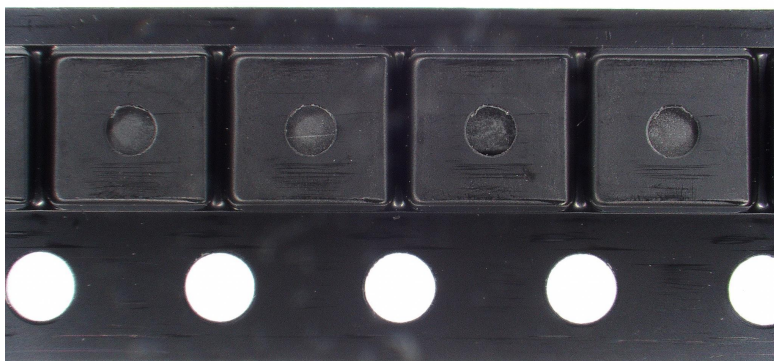
Fig4

Tape Back

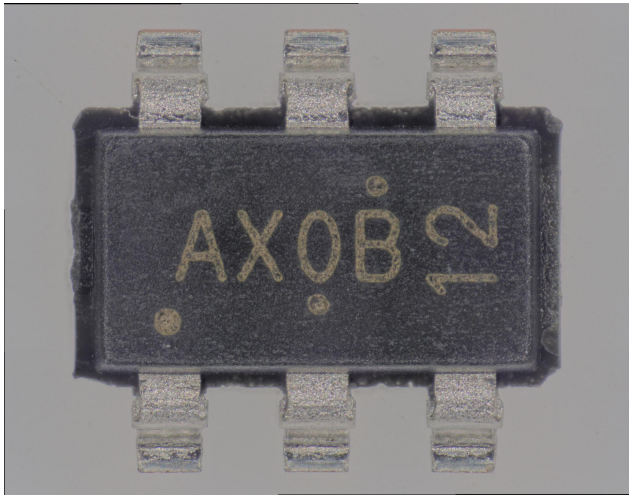
Fig7

Marking , typing version, typesetting and other comparison is consistent, chip packaging is not abnormal.

Top View

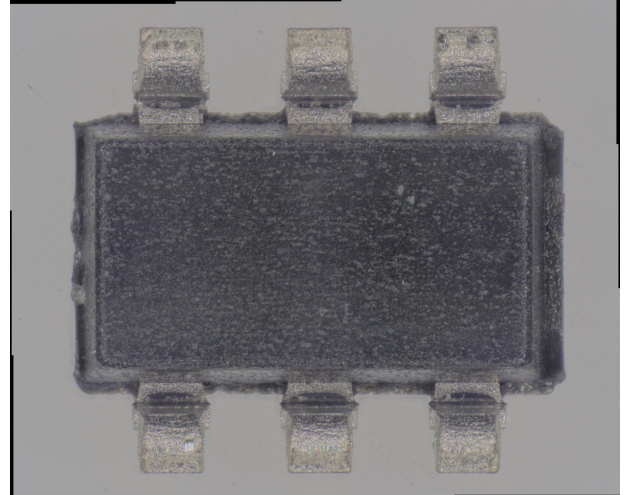
Fig8

Bottom View

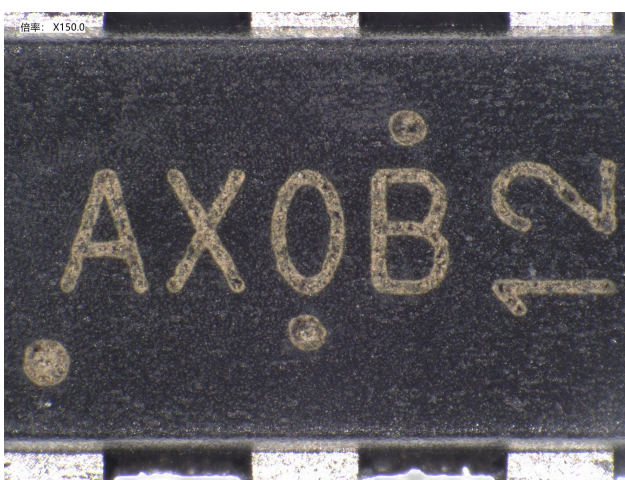
Fig9

The marking on the surface of the sample is clear, the granularity is obvious, the shape of the marking is regular, and there is no trace of secondary polishing;

Sample Marking

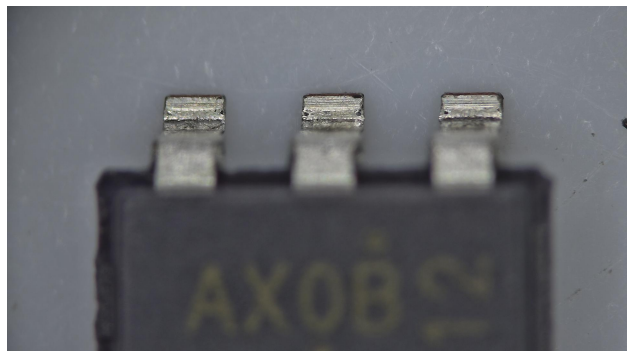
Fig11

The tin on the pin is uniform without abnormal, the cross-section of the exposed copper substrate is a normal phenomenon, there is no obvious sanding characteristics, the overall condition is good.

Top View of Pin

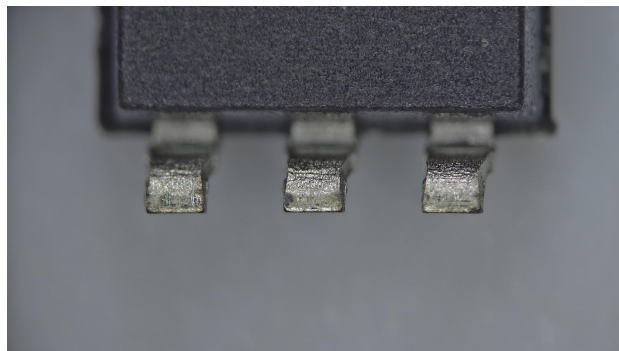
Fig12

Bottom View of Pin

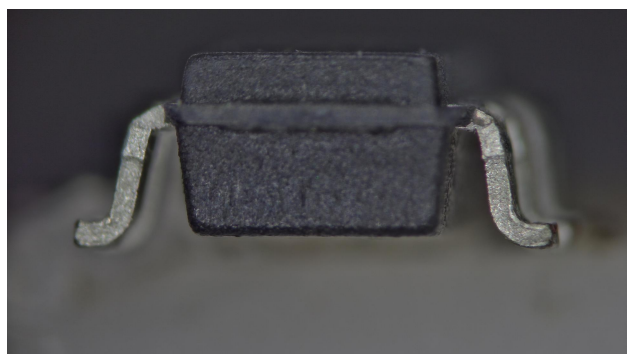
Fig13

Side View of Pin

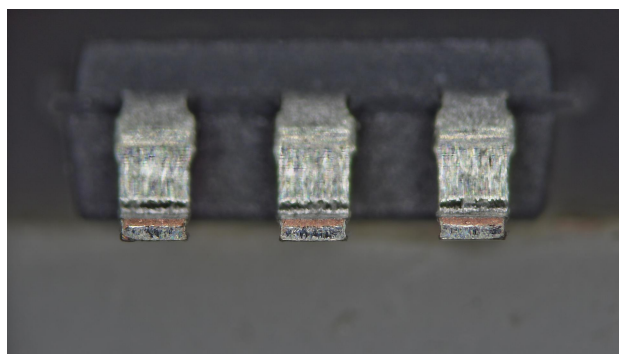
Fig14

Pin cross-section

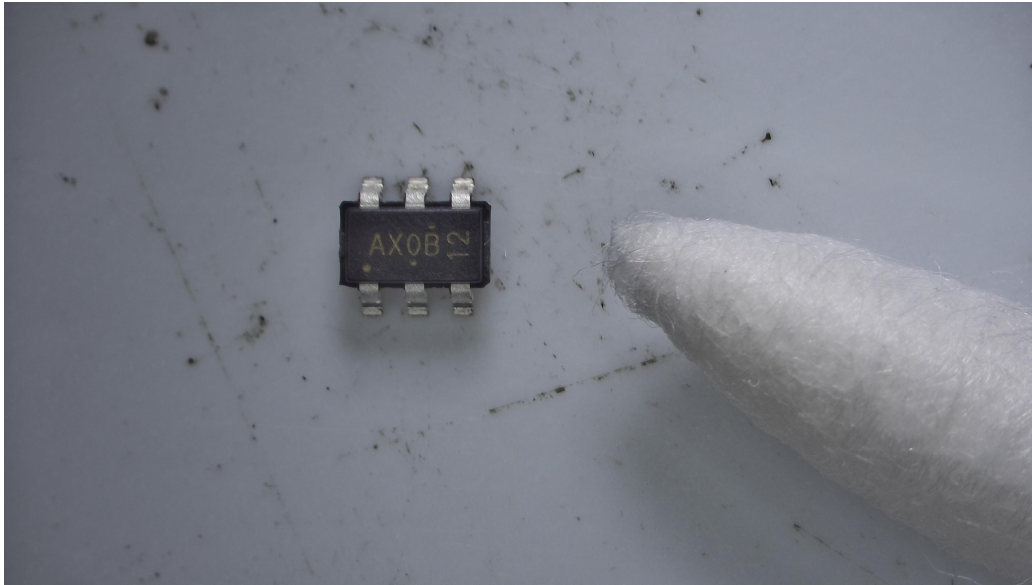
Fig15

After the surface and side of the sample were wiped back and forth with acetone for 3 times, the mark was still clearly visible, there was no obvious secondary coating, the depth of the mark did not change significantly under the EMS(Electron Microscope Scan),and the cotton swab was not blackened and other abnormal phenomena.

Acetone Test

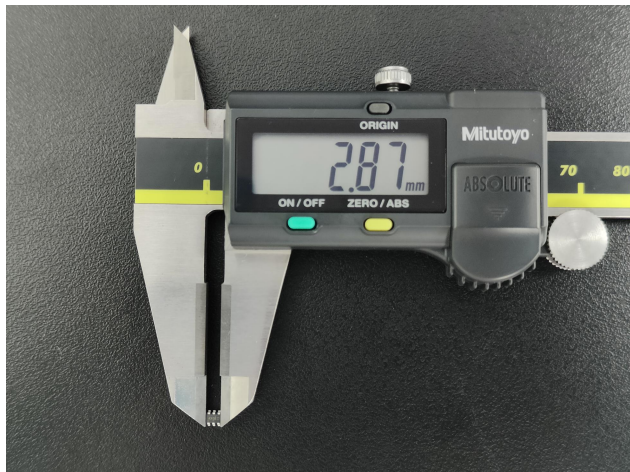
Fig18

- All size of the samples meet the requirement of the specifications.

Length: 2.87mm

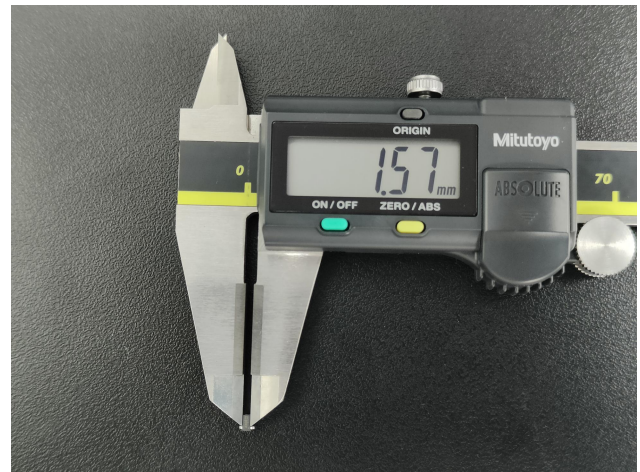
Fig19

Width: 1.57mm

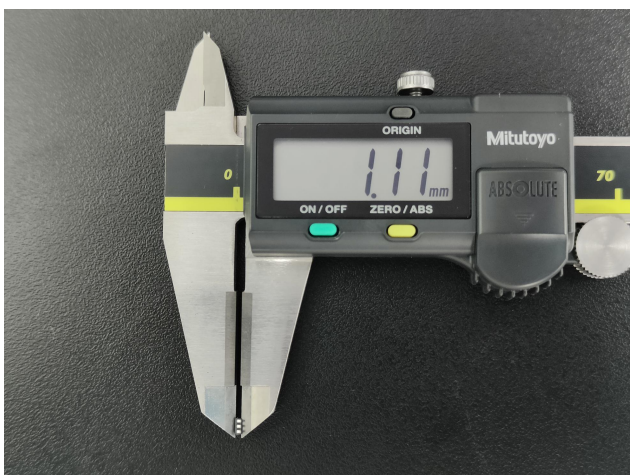
Fig20

Thicknesses: 1.11mm

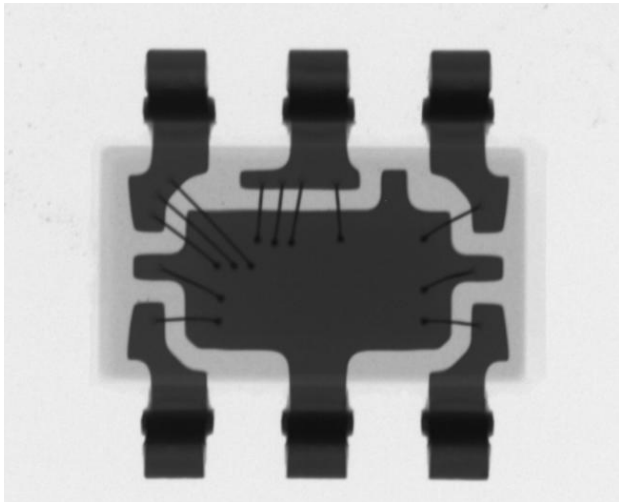
Fig24

• X-RAY: The internal structure of the sample is intact, the interface at the output terminal well welded, there were no abnormalities such as broken wires or crossings in the inner coils.

Top View

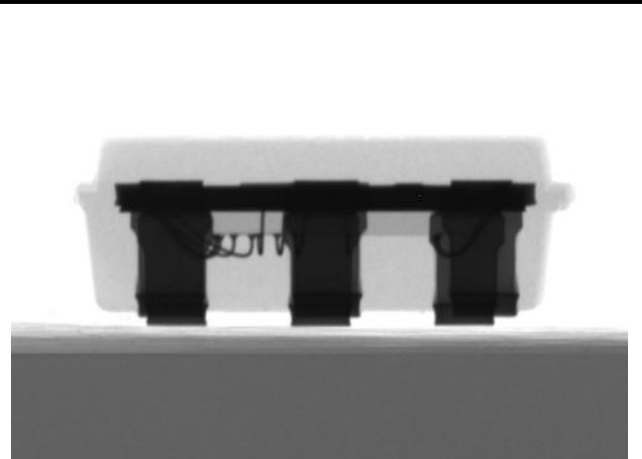
Fig25

Side View

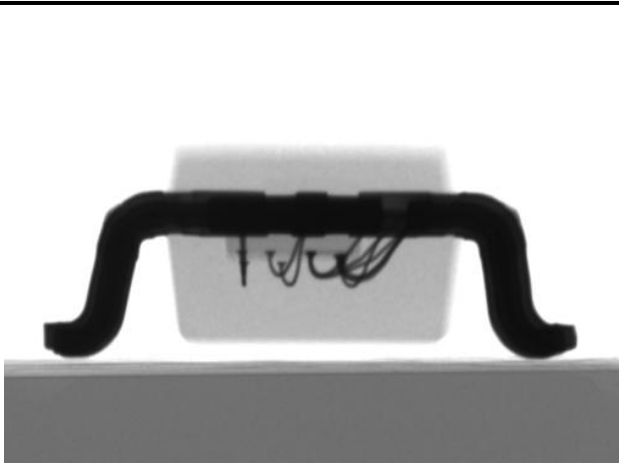
Fig26

Side View
