Inspection Report

Report No:	KHT-20250422-042	Sales:	JAX	Department Of Application	Sales
Receipt Date:	2025-04-18	Test Date:	2025-04-18	Report Date:	2025-04-22
Inspector:	周亚龙	Approved by:	黄浩泽	Approved by:	郭亚彬

Sample Information					
Part Number:	AOZ1280CI	Package Type:	SOT23	D/C:	25+
Package Carrier:	REEL	Manufacturer:	AOS	MSL:	1
Quantity Received:	2090pcs	Quantity Inspected:	5pcs	PO Number:	KTD2524219
Incoming information: The incoming goods are a section of tape ,there is no original packaging and original labeling .The packing and tape show no damage, no popping or other abnormal phenomena.

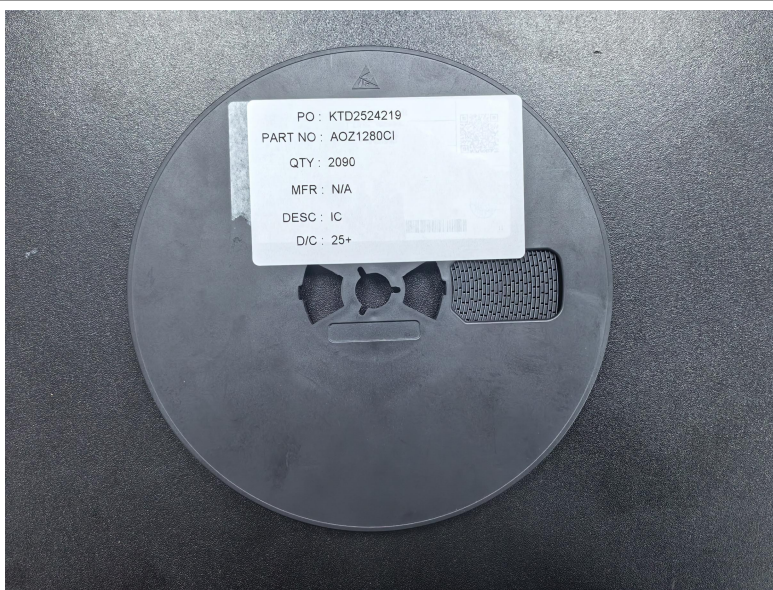
Fig1

Labels are clear, no alterations, label information checks out; typed versions, typography, etc. conform to original factory characteristics.

Arrival picture

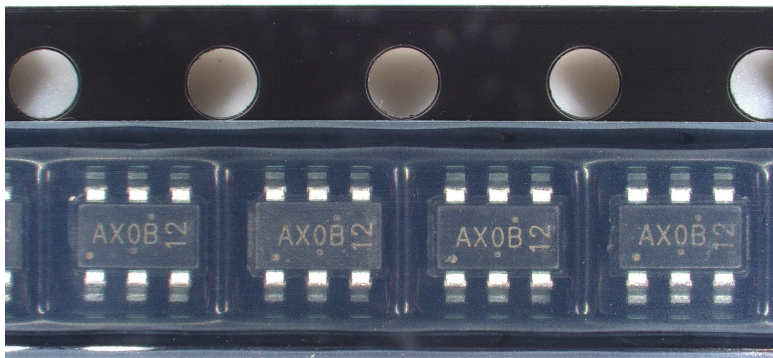
Fig3

The braided tape has no tears or burst tapes, meets the specifications of the specification, is a clear film with even indentations, and conforms to the original characteristics.

Tape Front

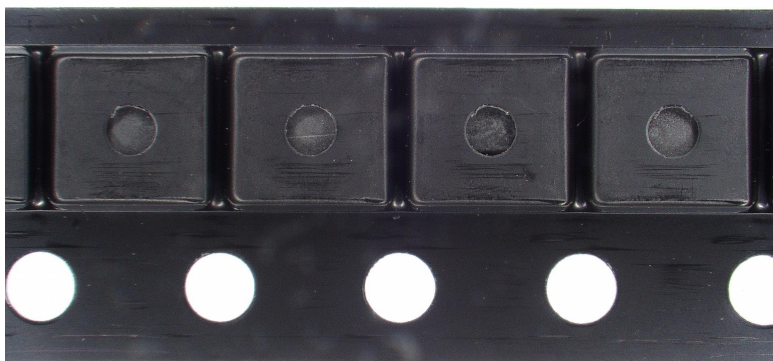
Fig4

Tape Back

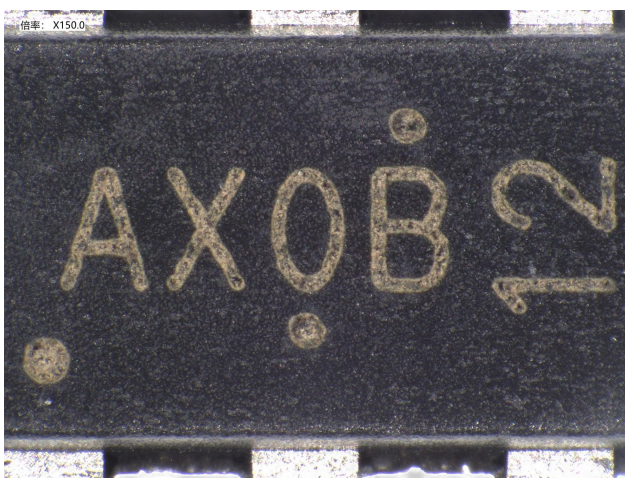
Fig9

The marking on the surface of the sample is clear, the granularity is obvious, the shape of the marking is regular, and there is no trace of secondary polishing;

Sample Marking

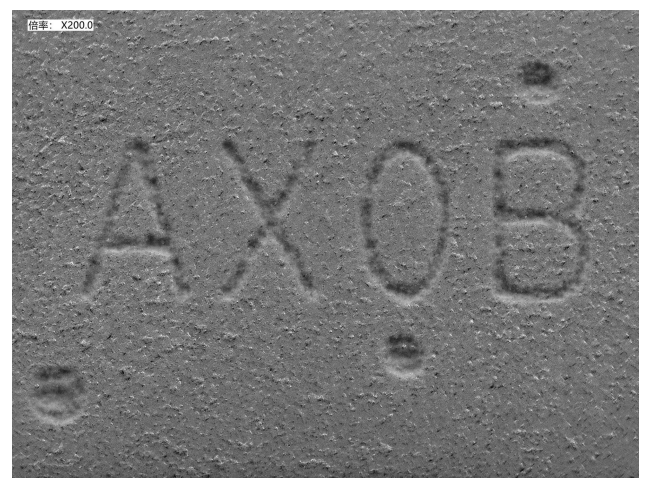
Fig10

Opt-SEM

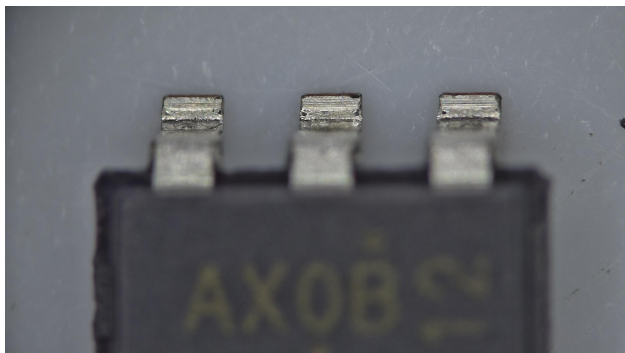
Fig11

The tin on the pin is uniform without abnormal, the cross-section of the exposed copper substrate is a normal phenomenon, there is no obvious sanding characteristics, the overall condition is good.

Top View of Pin

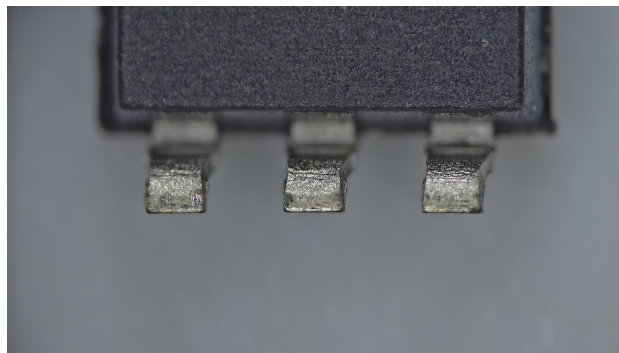
Fig12

Bottom View of Pin

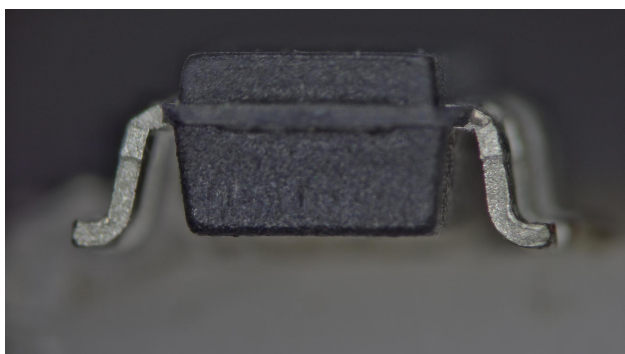
Fig13

Side View of Pin

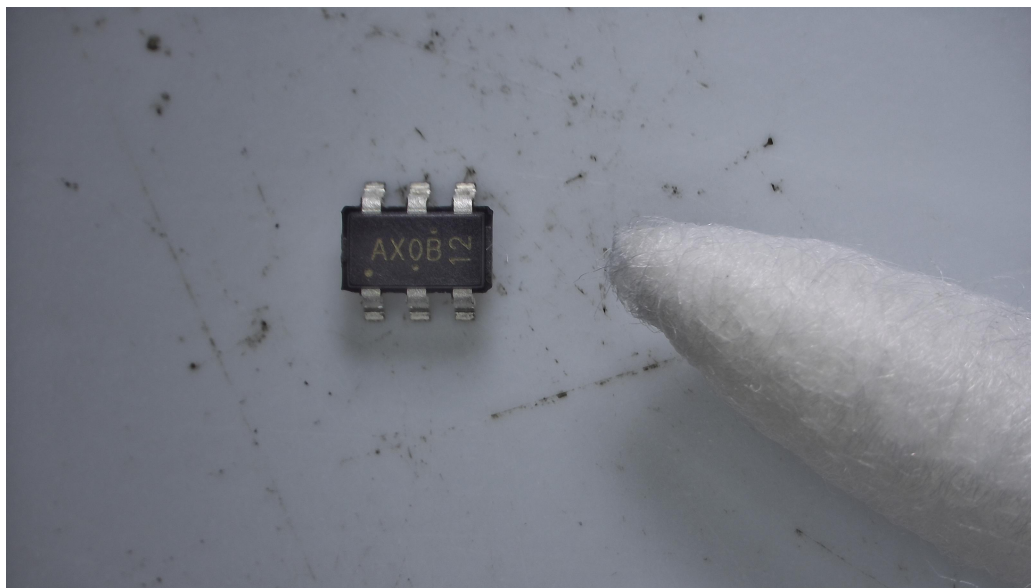
Fig15

After the surface and side of the sample were wiped back and forth with acetone for 3 times, the mark was still clearly visible, there was no obvious secondary coating, the depth of the mark did not change significantly under the EMS(Electron Microscope Scan),and the cotton swab was not blackened and other abnormal phenomena.

Acetone Test

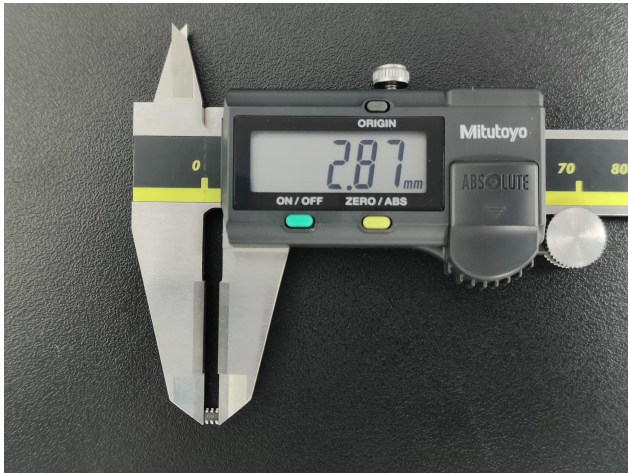
Fig18

- All size of the samples meet the requirement of the specifications.

Length: 2.87mm

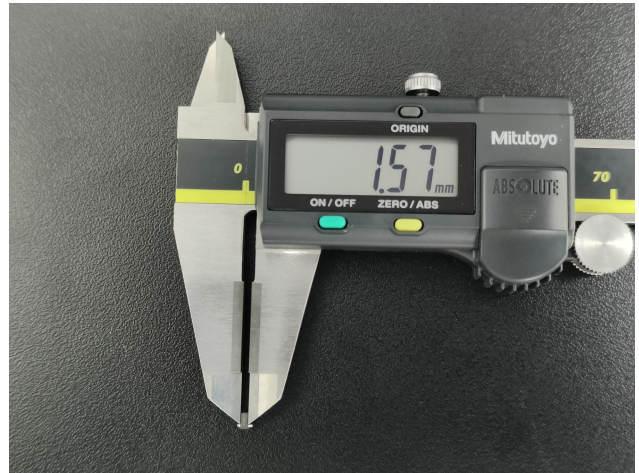
Fig19

Width: 1.57mm

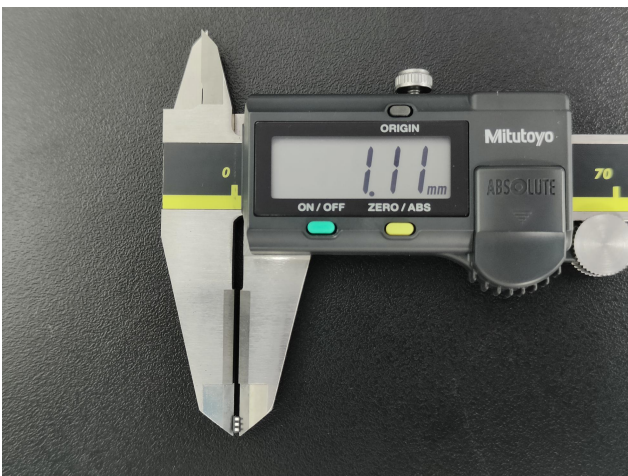
Fig20

Thicknesses: 1.11mm

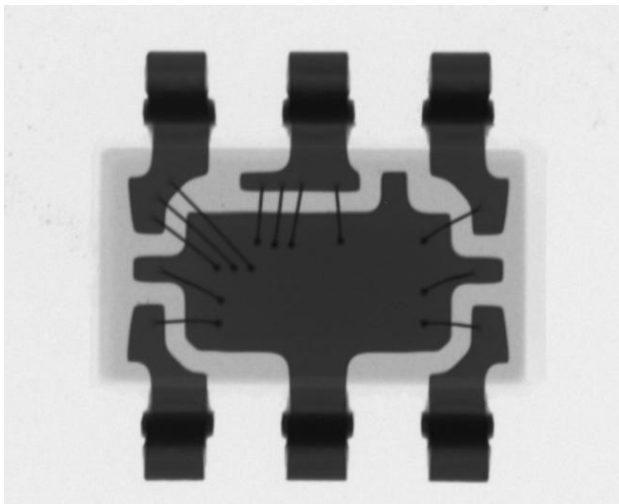
Fig24

• X-RAY: The internal structure of the sample is intact, the interface at the output terminal well welded, there were no abnormalities such as broken wires or crossings in the inner coils.

Top View

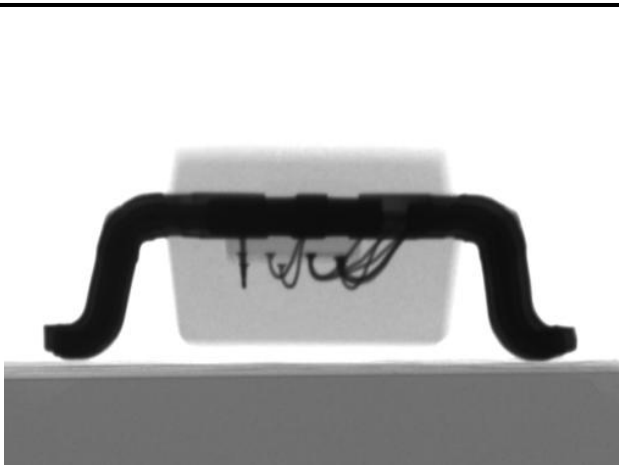
Fig26

Side View
