Inspection Report

Report No:	KHT-20251020-057	Sales:	Daniel Yuan	Department Of Application	Sales
Receipt Date:	2025-10-18	Test Date:	2025-10-18	Report Date:	2025-10-20
Inspector:	<i>Wade</i>	Approved by:	<i>David</i>	Approved by:	<i>Jam Guo</i>

Sample Information					
Part Number:	XC18V512SO20C	Package Type:	SOP20	D/C:	0413+
Package Carrier:	TUBE	Manufacturer:	XILINX	MSL:	1
Quantity Received:	125pcs	Quantity Inspected:	5pcs	PO Number:	50471
Incoming information : The goods are delivered in tubes. Have no original packaging and original labels, The packing and tape show no damage, no popping or other abnormal phenomena.

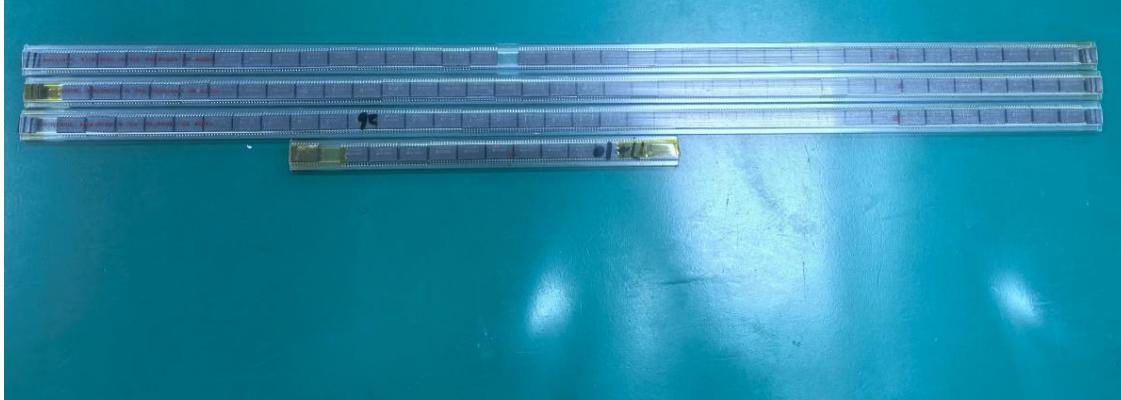
Fig1

Labels are clear, no alterations, label information checks out; typed versions, typography, etc. conform to original factory characteristics.

Arrival picture

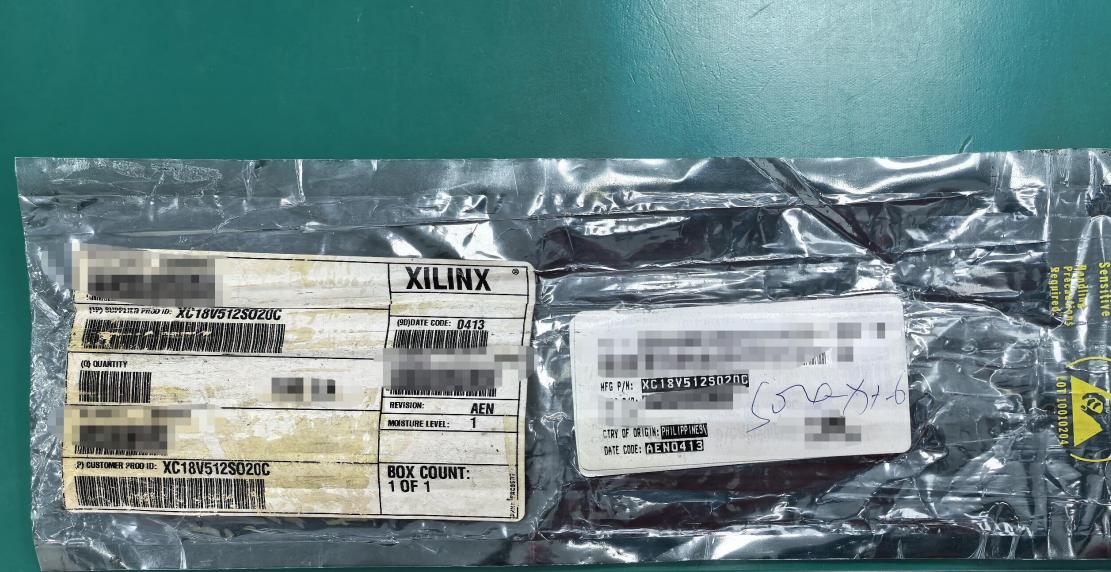
Fig2

Arrival label

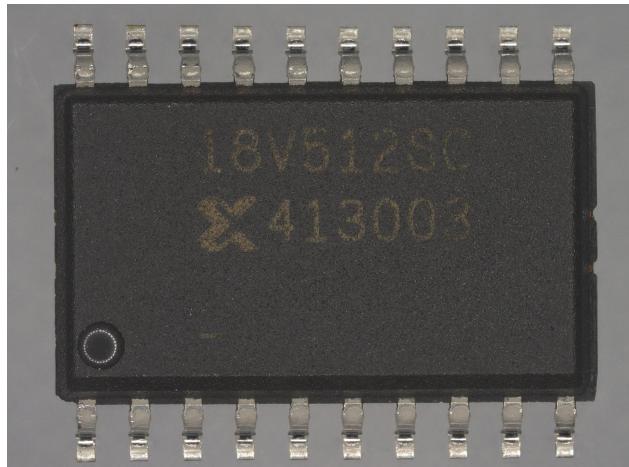
Fig4

Marking , typing version, typesetting and other comparison is consistent, chip packaging is not abnormal.

Top View

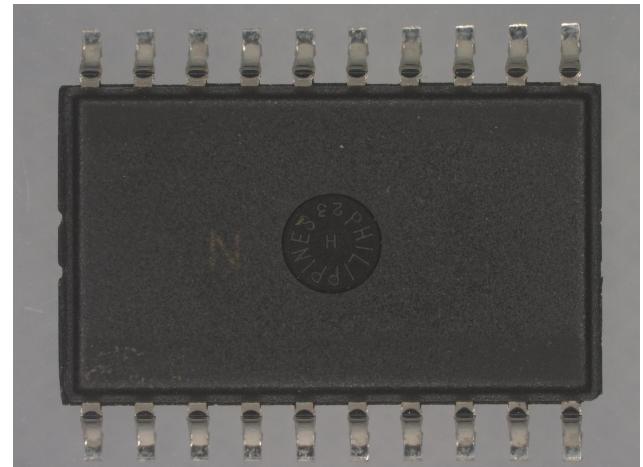
Fig5

Bottom View

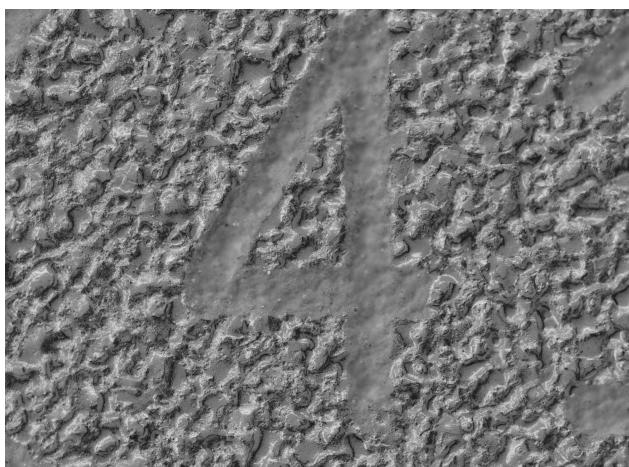
Fig6

The marking on the surface of the sample is clear, the granularity is obvious, the shape of the marking is regular, and there is no trace of secondary polishing;

Sample Marking

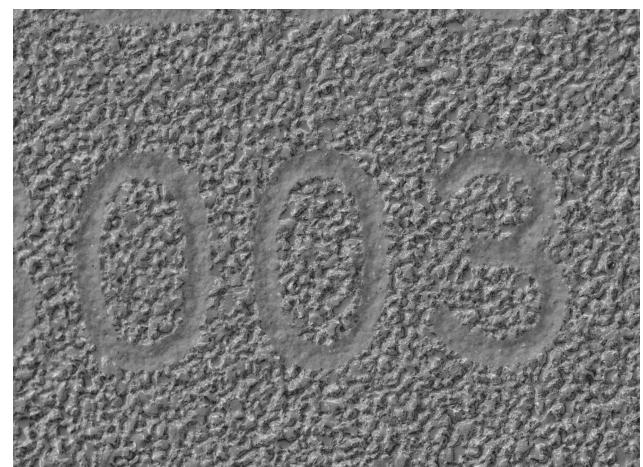
Fig7

Opt-SEM

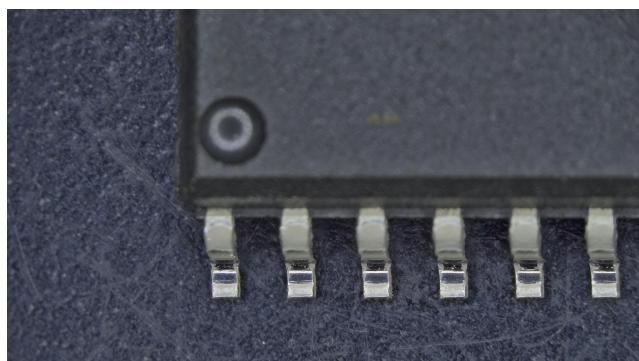
Fig8

The tin on the pin is uniform without abnormal, the cross-section of the exposed copper substrate is a normal phenomenon, there is no obvious sanding characteristics, the overall condition is good.

Top View of Pin

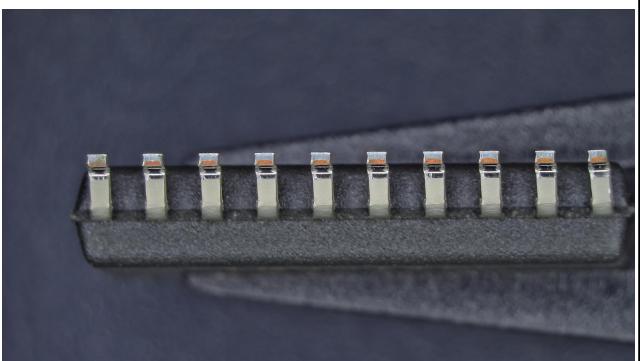
Fig9

Pin Cross-section

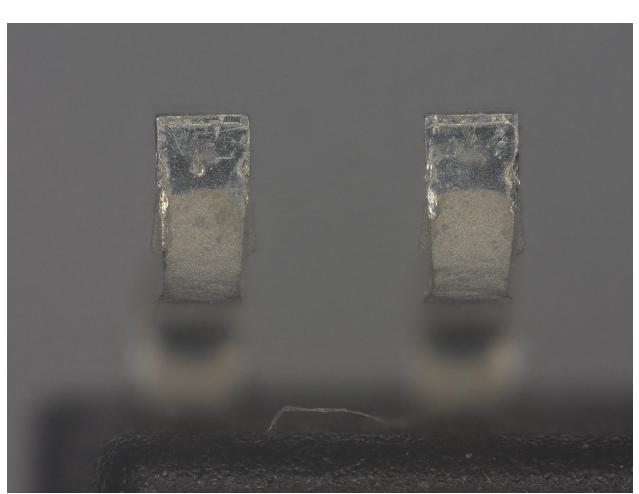
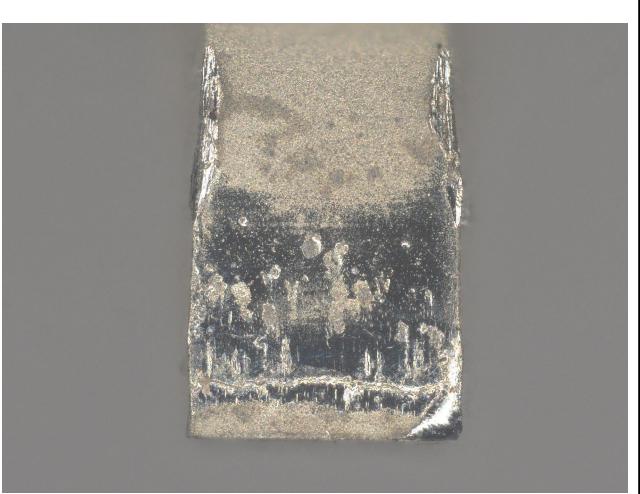
Bottom View of Pin

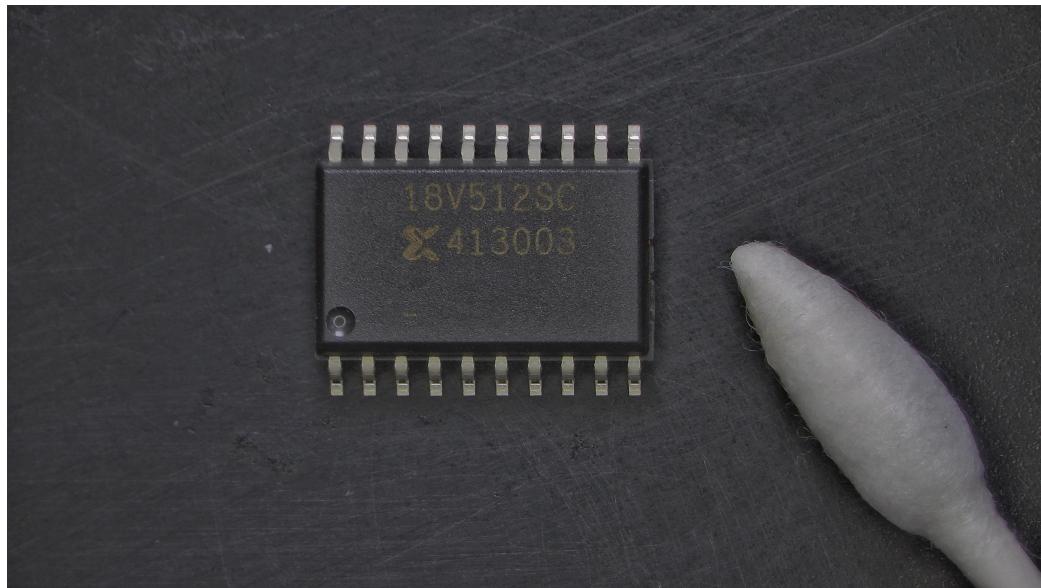
Fig12

After the surface and side of the sample were wiped back and forth with acetone for 3 times, the mark was still clearly visible, there was no obvious secondary coating, and the cotton swab was not blackened and other abnormal phenomena.

Acetone Test

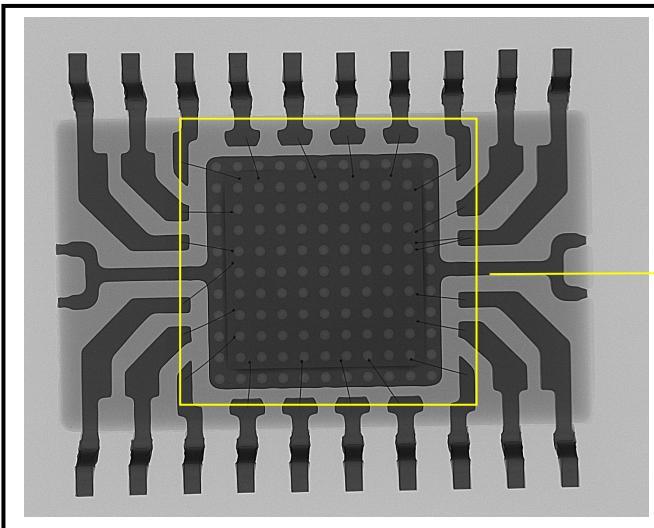
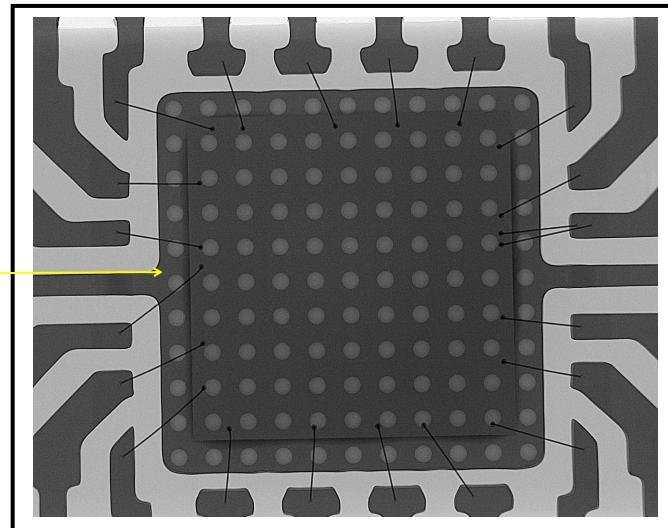
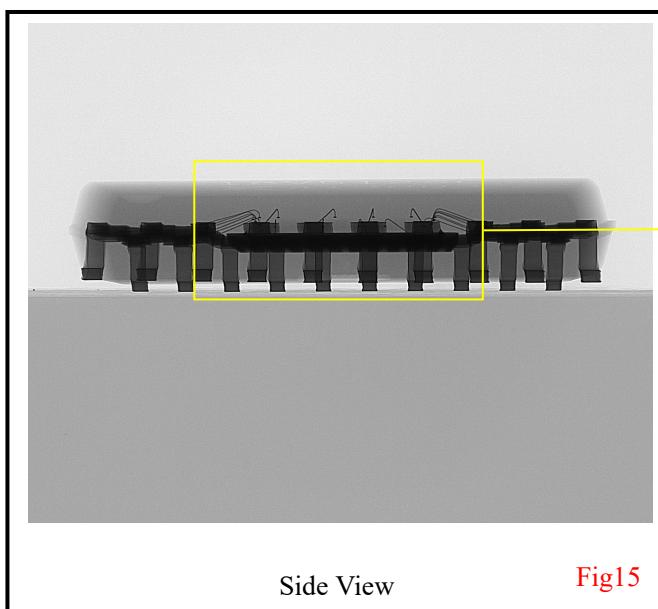
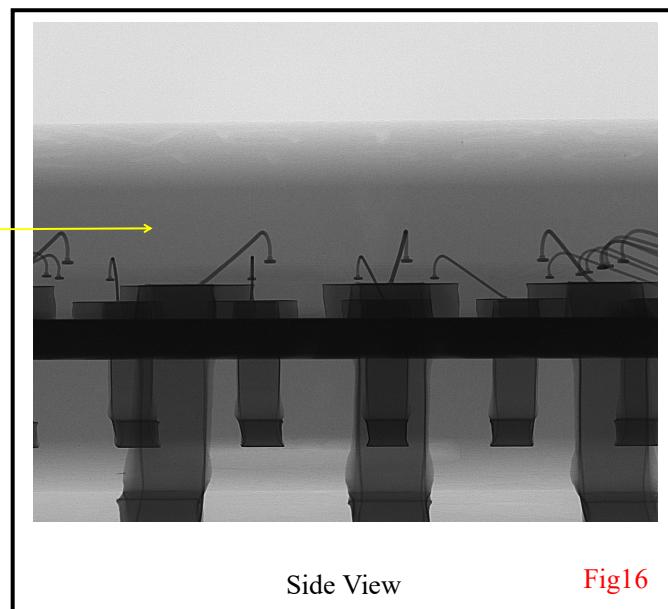
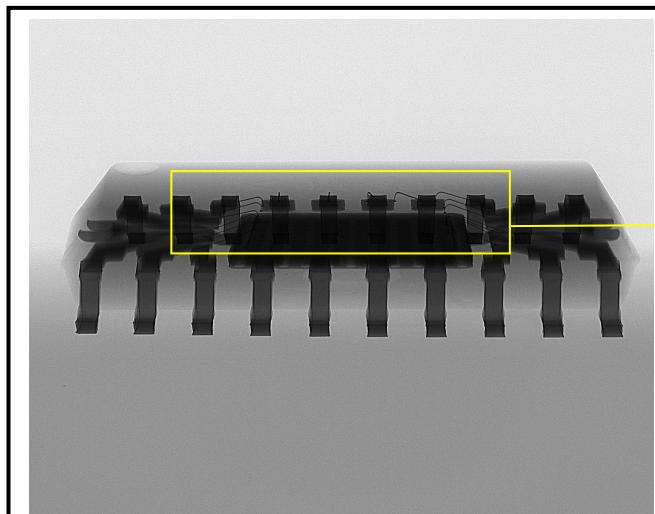
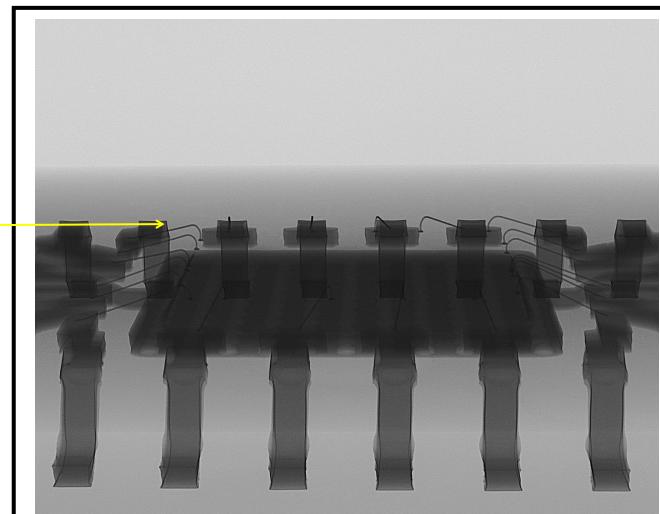
- X-RAY: The internal structure of the sample is intact, the interface at the output terminal well welded, there were no abnormalities such as broken wires or crossings in the inner coils.

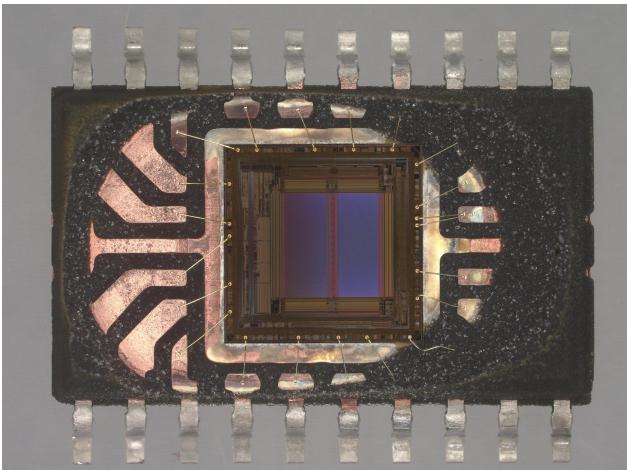
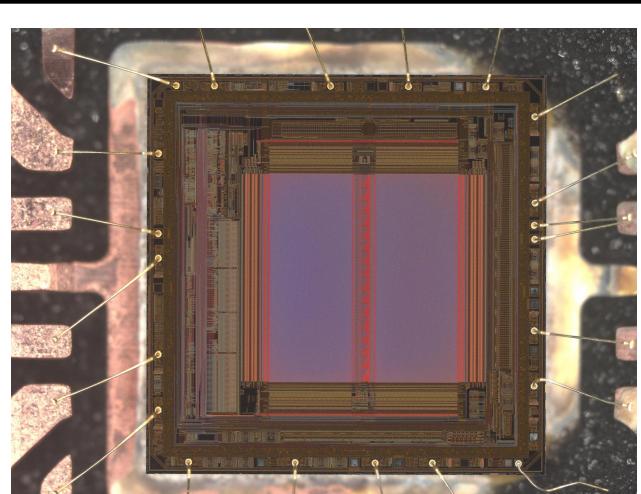
- De-cap die analysis according to the standard , After opening the die, it was found that the internal structure was complete , The inside of the wafer displays information such as "X6400" "XILINX", It is judged to be made by the original factory.

Wafer architecture

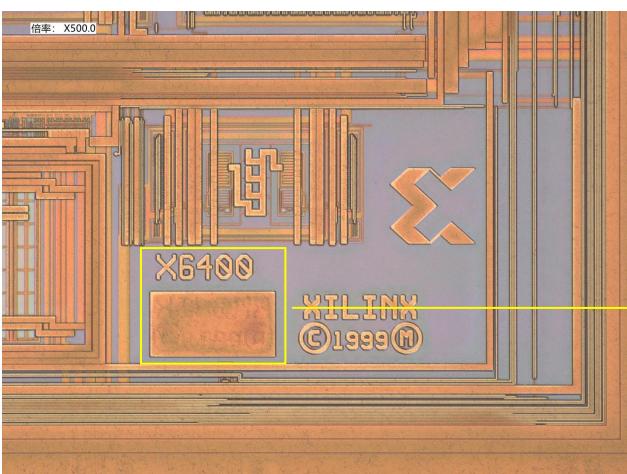
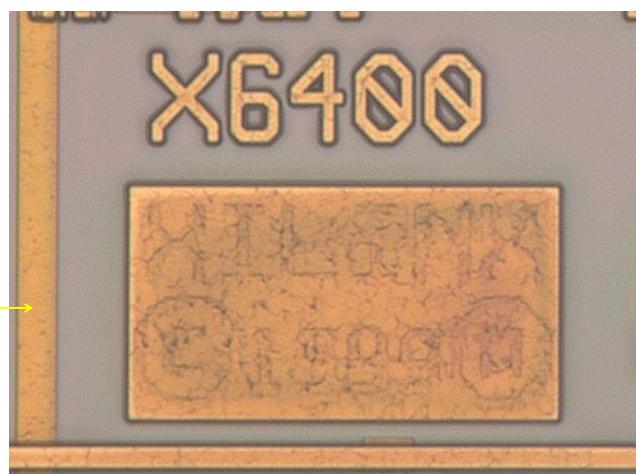
Wafer information

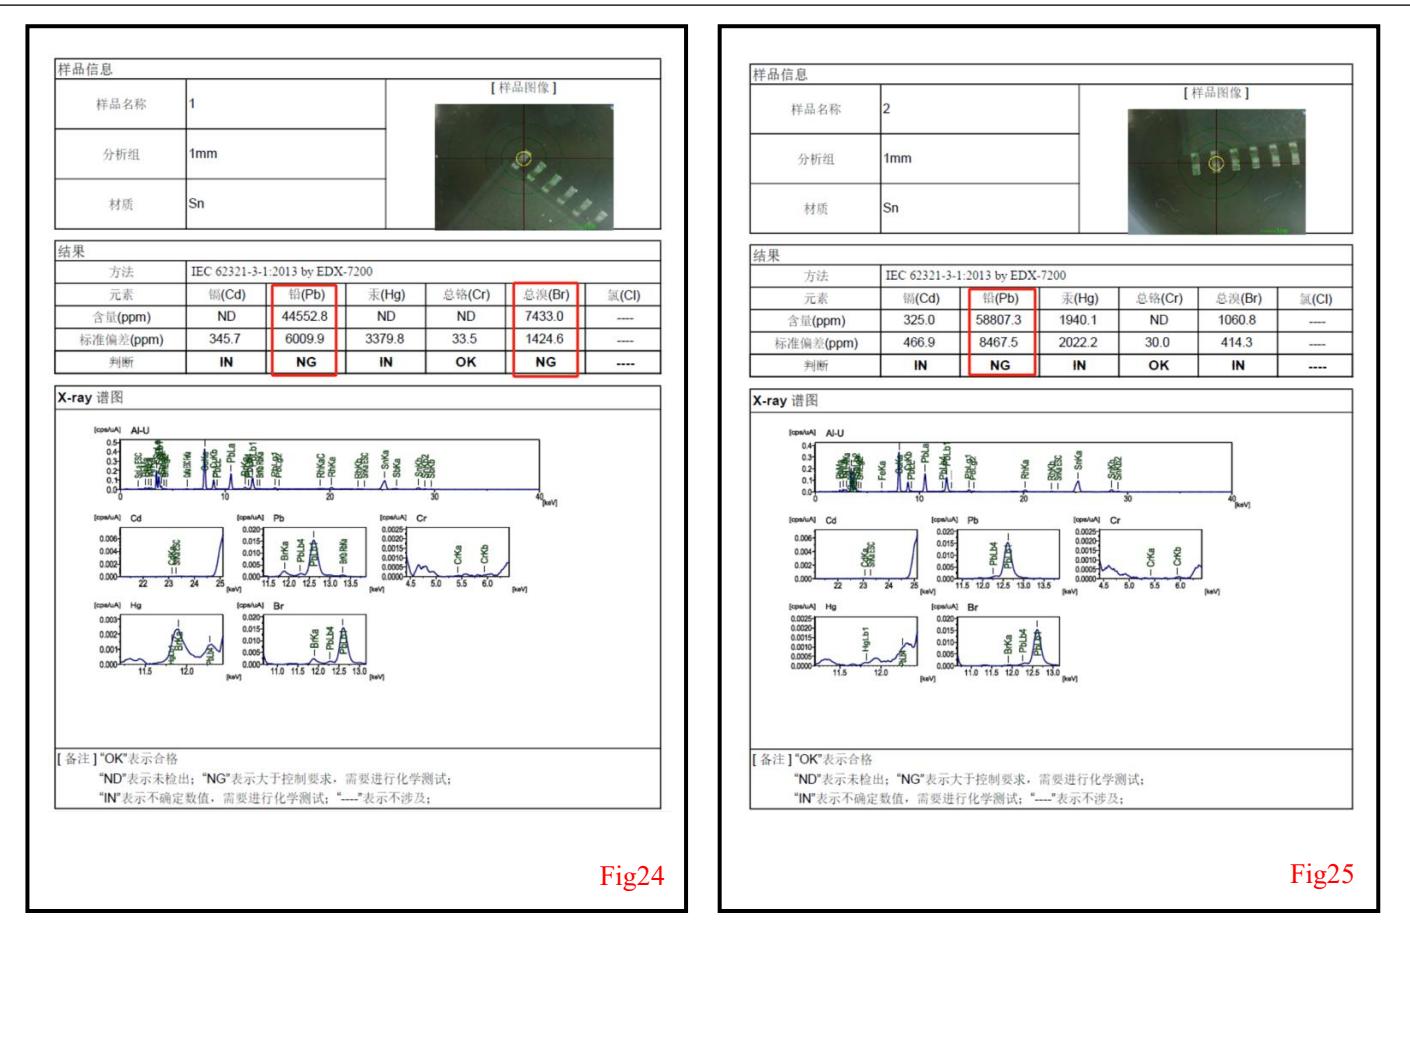
4.RoHS Test

Conclusion and Suggestions	
Conclusion and Suggestions	
Conclusion:	Incoming 125pcs for the same batch, 5pcs were detected by sampling detection method, EVI passed, X-RAY test passed, De-cap Die Analysis passed, RoHS Test failed .
Suggestions:
