Inspection Report

Report No:	KHT-20250327-033	Sales:	Daniel Yuan	Department Of Application	Sales
Receipt Date:	2025-03-05	Test Date:	2025-03-05	Report Date:	2025-03-27
Inspector:	Wade	Approved by:	David	Approved by:	Jan Guo

Sample Information					
Part Number:	EP4CE40F23I7N	Package Type:	FBGA-484	D/C:	2307+
Package Carrier:	TRAY	Manufacturer:	ALTERA	MSL:	3
Quantity Received:	180pcs	Quantity Inspected:	5pcs	PO Number:	1215075524

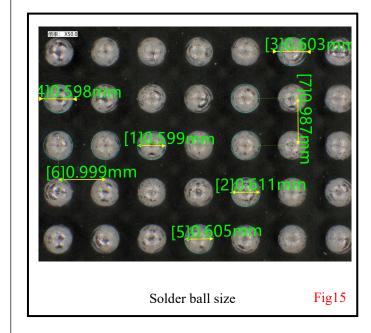
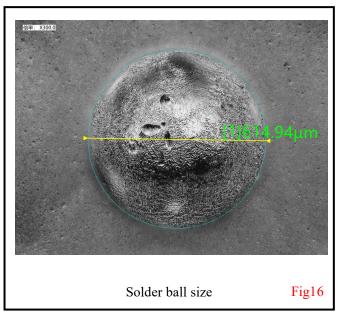
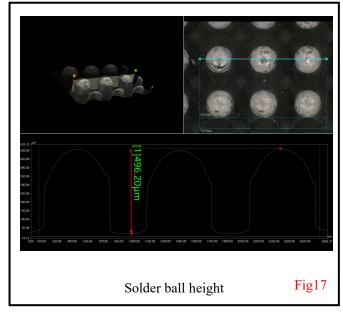
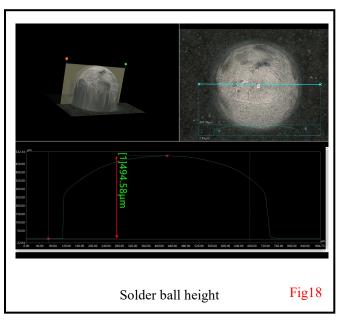
The diameter and height of the solder balls are in accordance with the specifications of the specification; Check the appearance of the solder balls one by one, there is no abnormality such as deformation and discoloration, the welding is good.

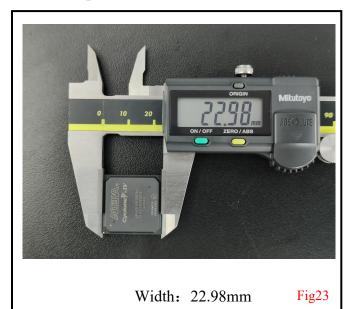
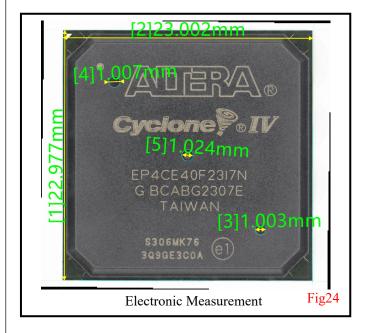
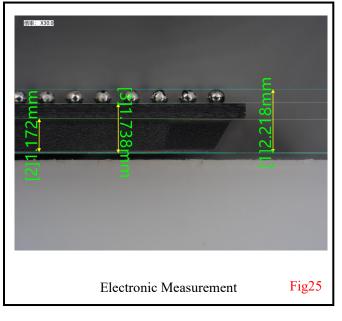
• All size of the samples meet the requirement of the specifications.

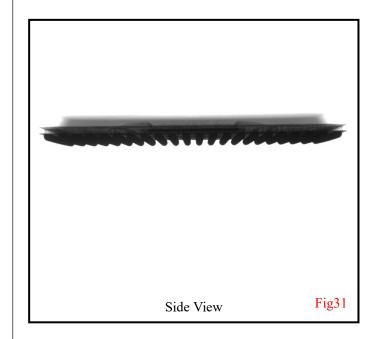
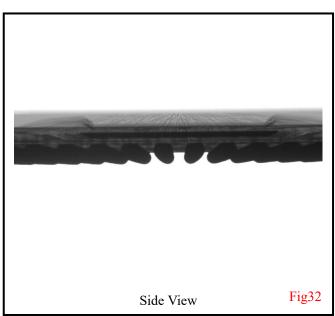
• X-RAY: The internal structure of the sample is intact, the interface at the output terminal well welded, there were no abnormalities such as broken wires or crossings in the inner coils.
