Inspection Report

| Report No: | KHT-20250422-042 | Sales: | JAX | Department Of Application | Sales |

| Sample Information | | | | | |
|---|---|---|---|---|---|
| Part Number: | AOZ1280CI | Package Type: | SOT23 | D/C: | 25+ |

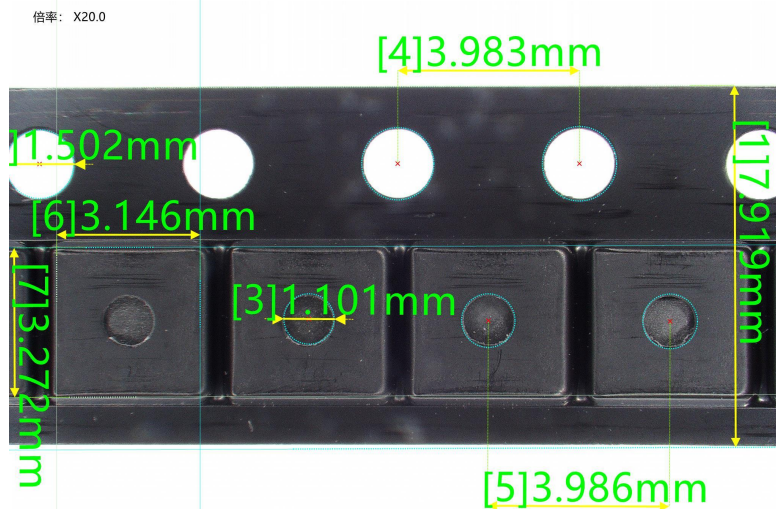
Fig4

Tape Back

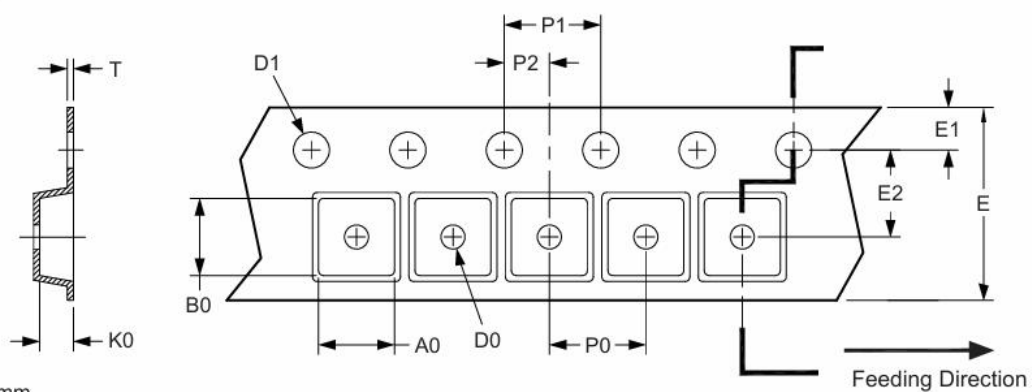
Fig5

Electronic measurements

Unit: mm

| Package | A0 | B0 | K0 | D0 | D1 | E | E1 | E2 | P0 | P1 | P2 | T |
| SOT-23 | 3.15<br>±0.10 | 3.27<br>±0.10 | 1.34<br>±0.10 | 1.10<br>±0.01 | 1.50<br>±0.10 | 8.00<br>±0.20 | 1.75<br>±0.10 | 3.50<br>±0.05 | 4.00<br>±0.10 | 4.00<br>±0.10 | 2.00<br>±0.10 | 0.25<br>±0.05 |

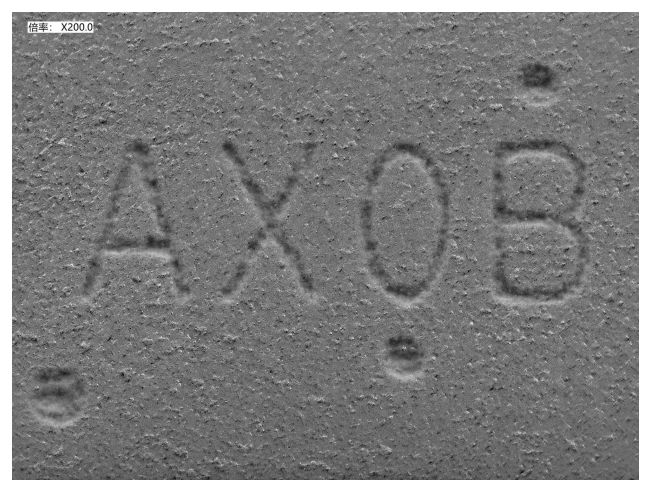
Fig10

The marking on the surface of the sample is clear, the granularity is obvious, the shape of the marking is regular, and there is no trace of secondary polishing;

Opt-SEM

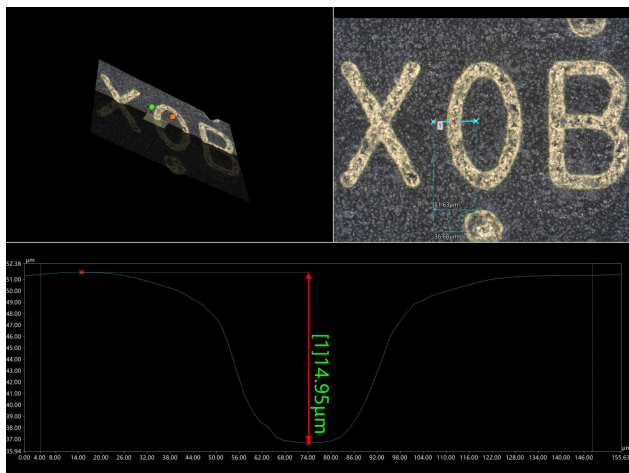
Fig16

After the surface and side of the sample were wiped back and forth with acetone for 3 times, the mark was still clearly visible, there was no obvious secondary coating, the depth of the mark did not change significantly under the EMS(Electron Microscope Scan),and the cotton swab was not blackened and other abnormal phenomena.

#1 Electronic measurements

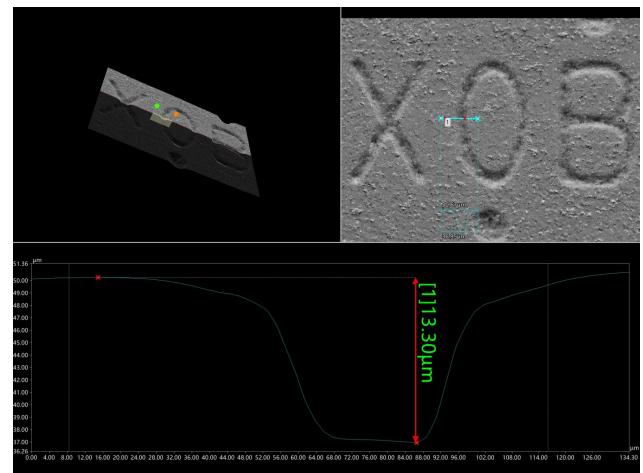
Fig17

#2 Electronic measurements

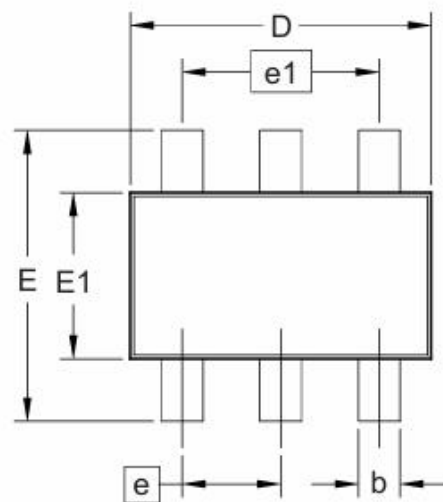
Fig21

- All size of the samples meet the requirement of the specifications.

Data Sheet

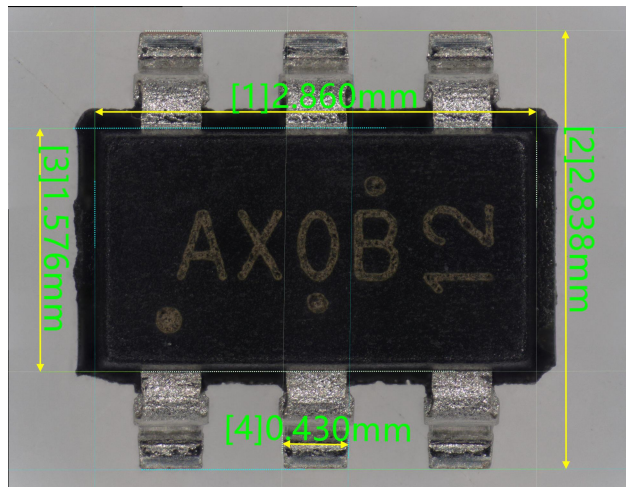
Fig22

#1 Electronic measurements

| Sample number | Length/mm | Width/mm | Thicknesses/mm | Result |
|---|---|---|---|---|
| #1 | 2.87 | 1.57 | 1.11 | PASS |

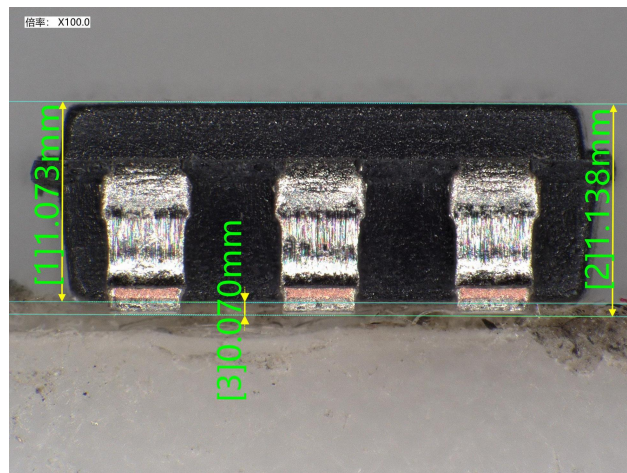
Fig23

#2 Electronic measurements

| Sample number | Length/mm | Width/mm | Thicknesses/mm | Result |
|---|---|---|---|---|
| #2 | 2.86 | 1.58 | 1.07 | PASS |

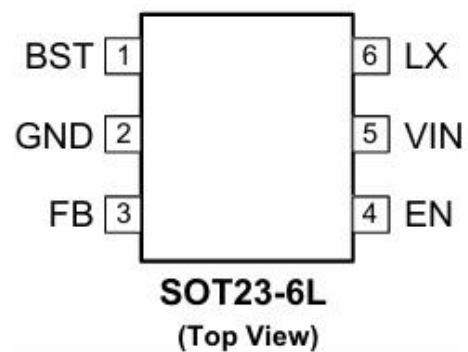
Fig27

• X-RAY: The internal structure of the sample is intact, the interface at the output terminal well welded, there were no abnormalities such as broken wires or crossings in the inner coils.

Pin Configuration
